# Lightning Strike on *Perseverance*

**CCA member Drew Plominski describes the lightning strike on his 30-foot racer-cruiser at its dock in Boston. His review of the damage and further thoughts follows.**

Outline of Observed Damage:

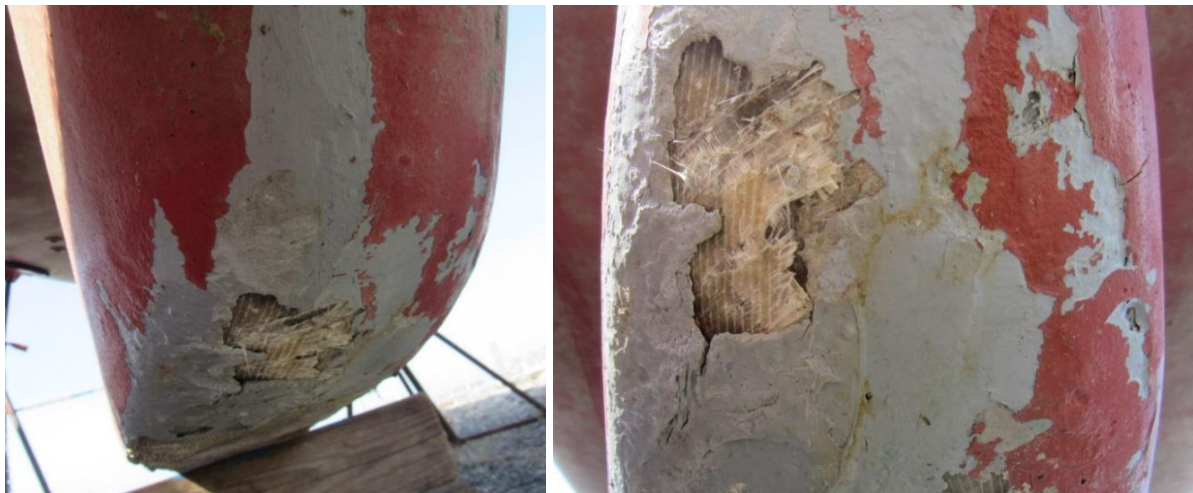
- Keel bottom damage (towards forward edge).

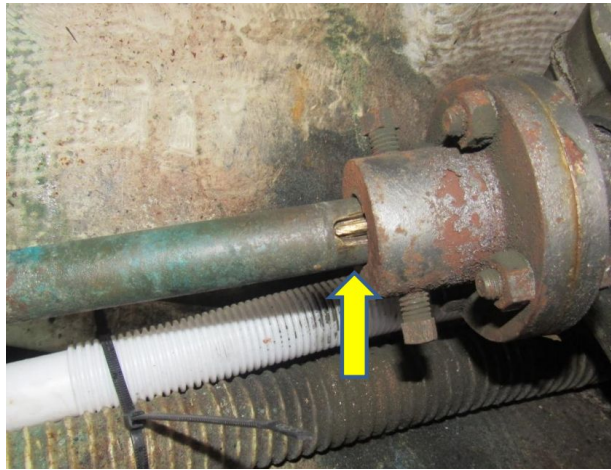
- Keel bottom damage (in way of lead ballast). New bottom completed for 2018 season. Fairing putty was blown off and fibers clearly oriented outwards into the water show discharge path through lead ballast.
- Shaft position out of coupling and key is loose

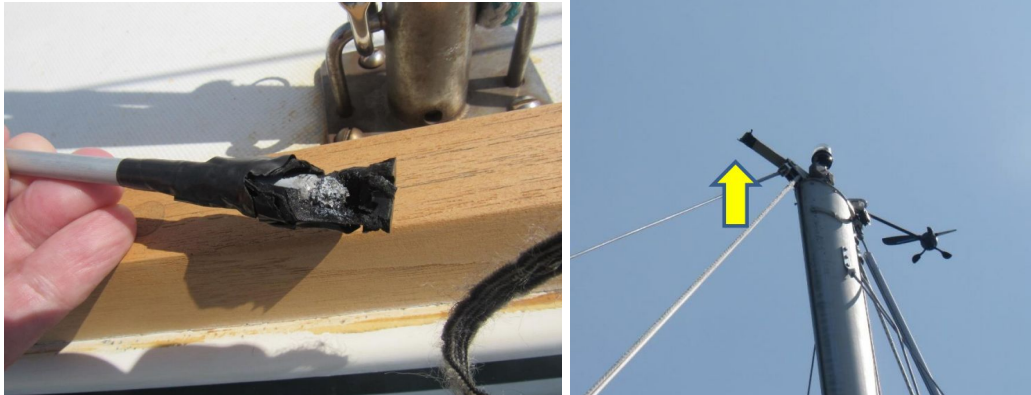
- Base of Windex post (post strike, this was found lying on deck)

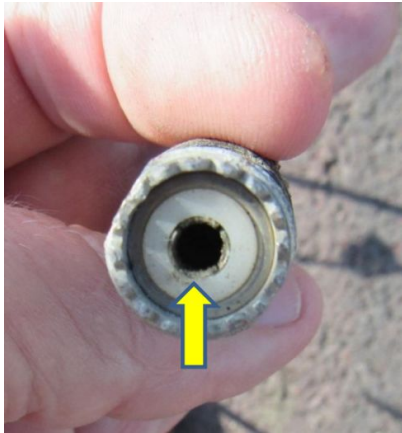
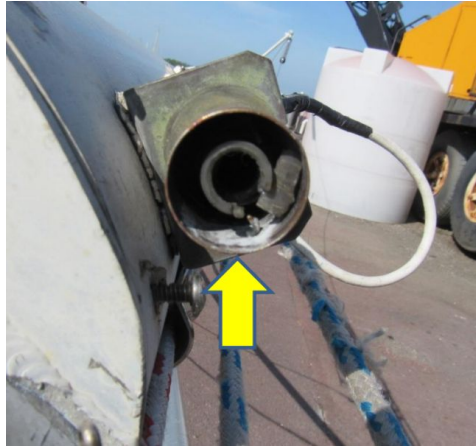
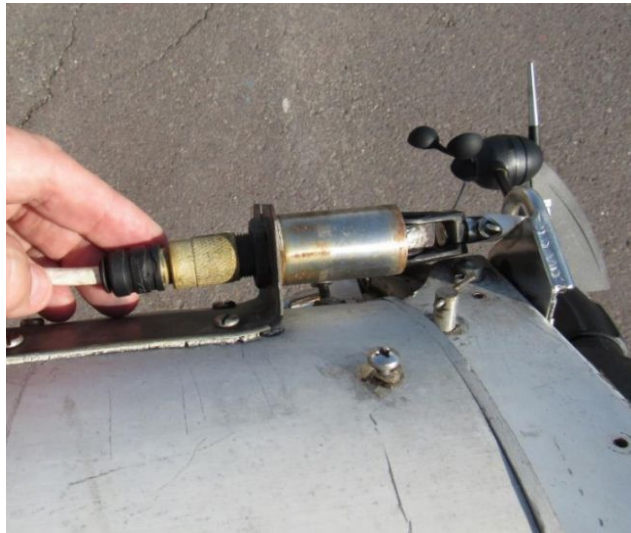
- VHF Antenna Cable connector at masthead
  - The entire interior conductor has disintegrated

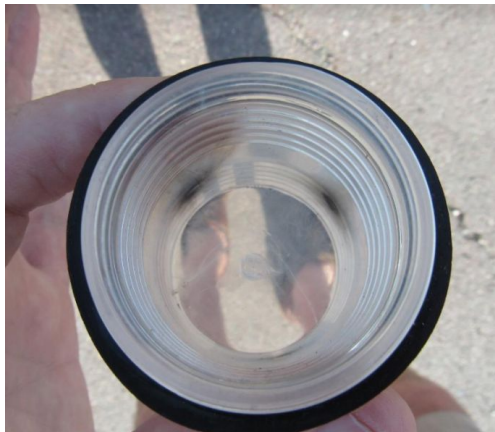
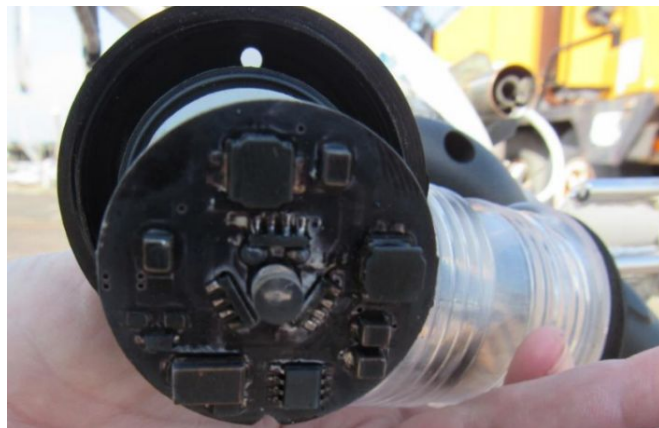
- Masthead Tricolor/Anchor Light exploded inside of clear housing. This was a Marinebeam.com model N3-TRI-CMB combination tricolor and anchor light.

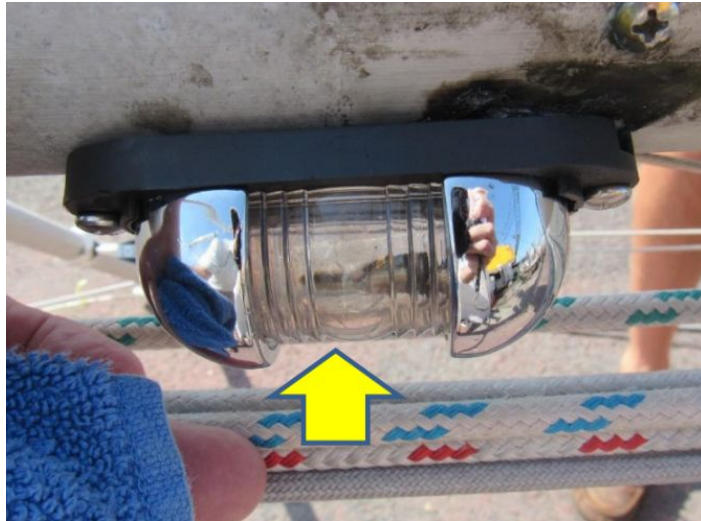
- Steaming light blown. This was brand new and rewired spring 2019. Blackness on right side of photo is from only, black plastic decklight fixture that was removed.

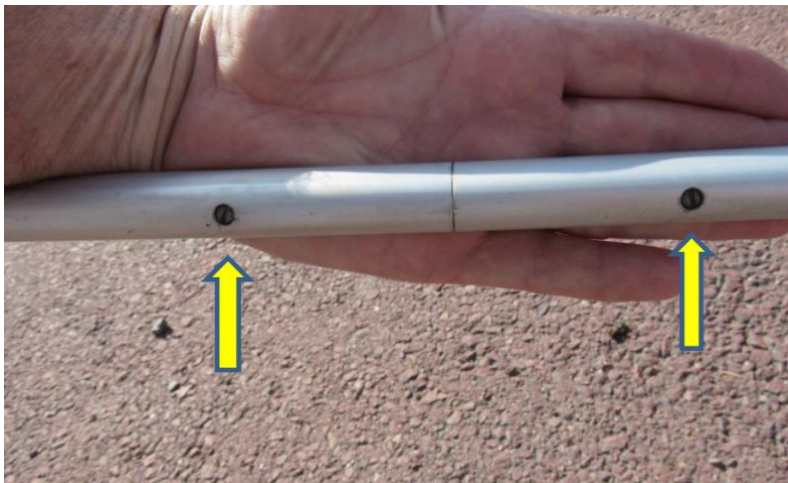
- Charring at headfoil junction fasteners

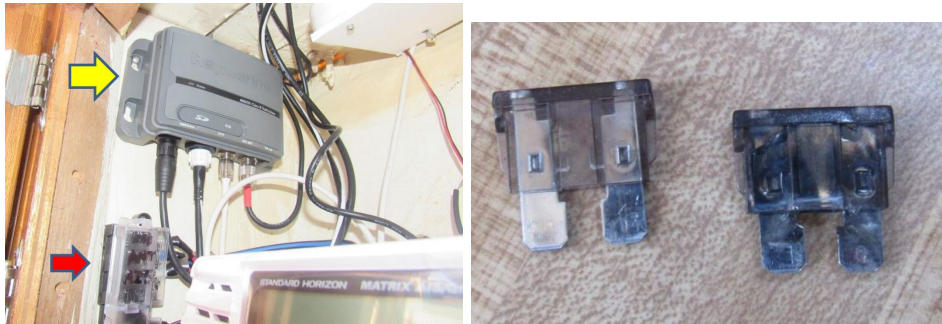
- Electronics Bus with AIS transceiver, VHF radio and other items in electrical cabinet.
  - AIS shown with Yellow Arrow, Electronics bus shown with Red
  - Dead fuses shown to the right
  - All equipment was brand new and installed spring of 2019.

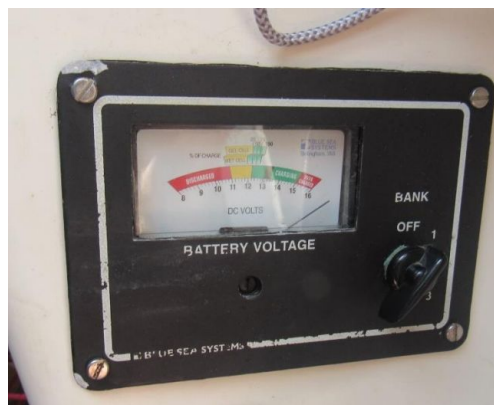
- Analog Battery monitor pegged off the scale.

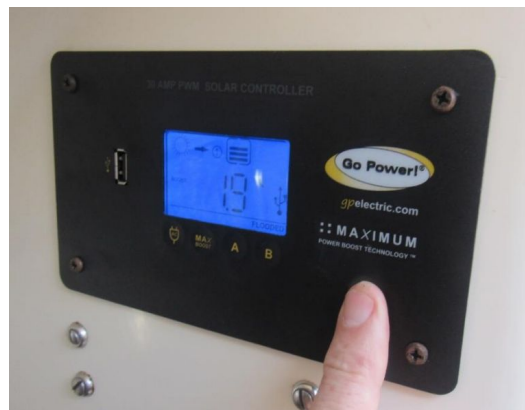
- Solar charge controller appeared to work but made clicking noise. It is hard to tell if this was still charging the house batteries or if they were overcharged from the lightning. There was not any visual evidence of the house batteries being damaged.

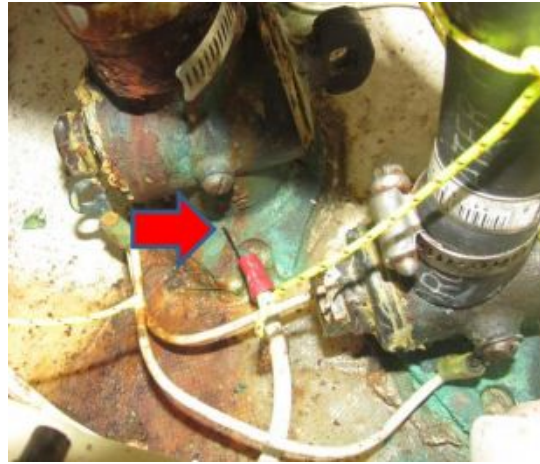
- Bonding conductors were attached at head sink discharge thru-hull and the connector melted away. Others had been disconnected by the previous owner.

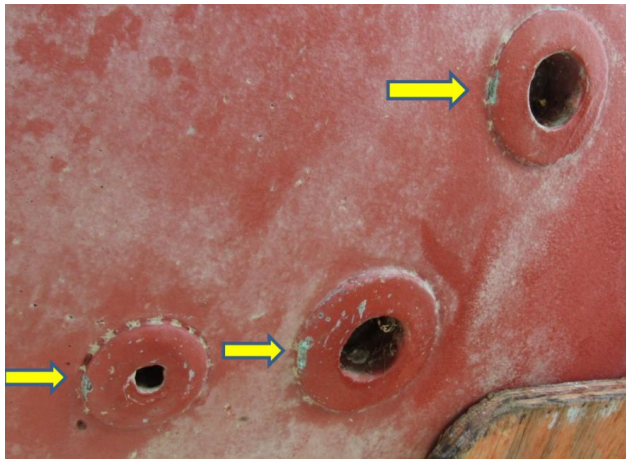
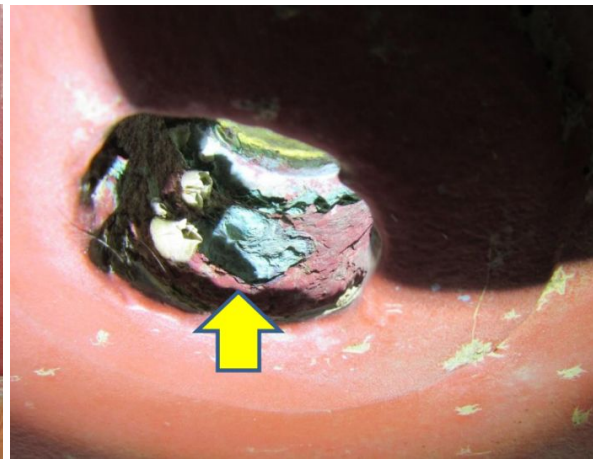
- Discharge through bronze thru-hulls

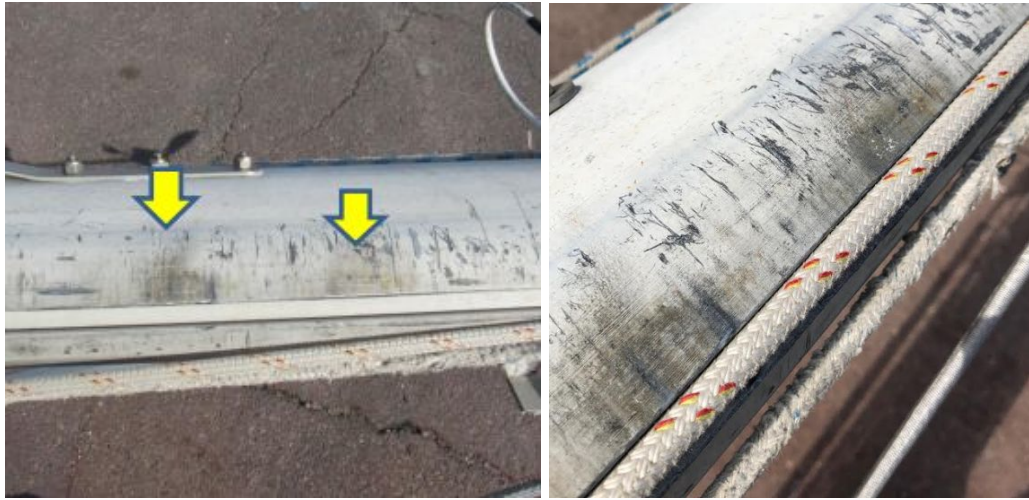
- Darkening on exterior of mast extrusion in way of worn/abraded locations. These areas are typically where the mainsail batten cars rub. They are usually smooth, clean

aluminum wear spots but now have black discoloration where they were otherwise clean aluminum.

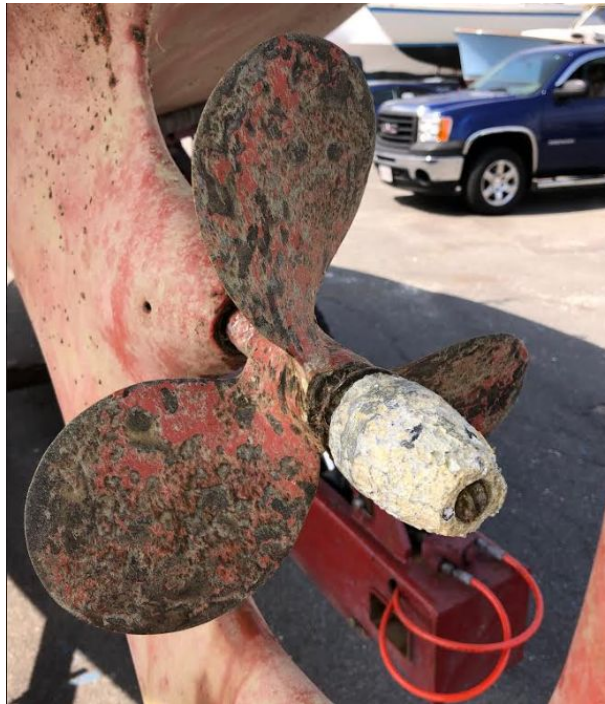
- Paint and primer on propeller was extremely pocked or missing. This paint was generally intact at the start of the 2019 season after minimal wear during the 2018 season. The propeller shaft zinc was brand new. This boat did not have shore power connectivity nor did she spend much time at the dock. The previous zinc had lasted 3 seasons and was only replaced as a precaution with less wear than shown below.

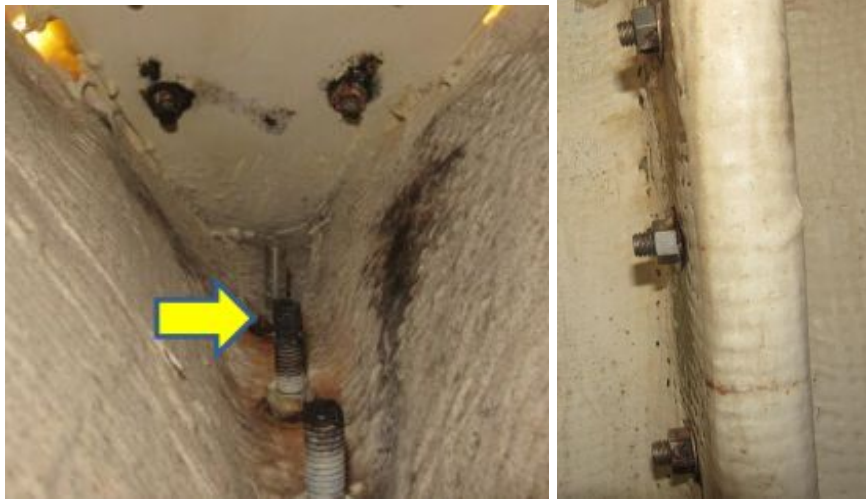
- Mounting hardware for stem fitting and chainplates shows evidence of high temperatures
