Replacing Old Profurl Bearings

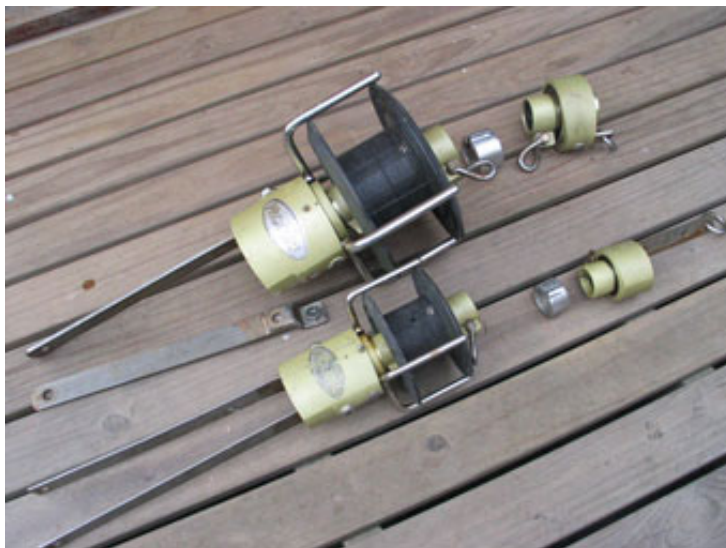
Starship's main working headsail is a high cut genoa, with a padded luff, on an N42 Profurl furler. The staysail is on a smaller N31 Profurl. Both furlers were purchased new in 1988 from Profurl's Australian agent, and worked reliably throughout our circumnavigation. In 2003, after a period of disuse I discovered the furling drums and the halyard carriers on both units had become very difficult to rotate by hand. Evidently moisture had got past the seals and was rusting the bearings (and as it turned out, the seal shells).

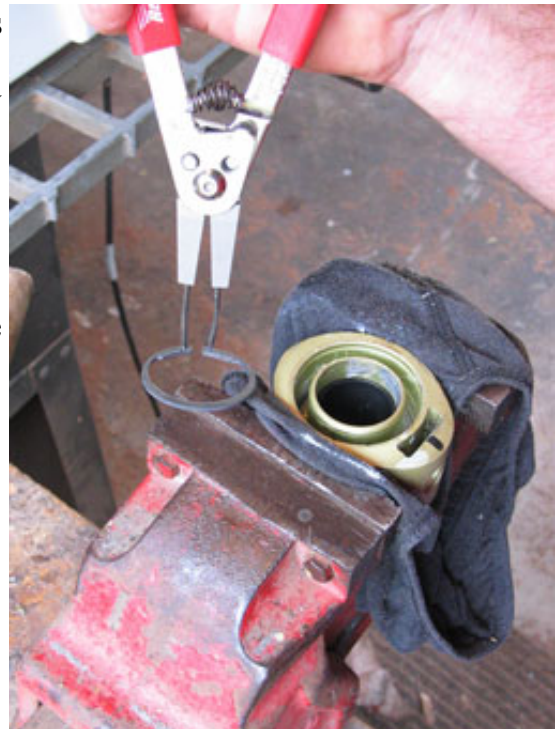
The photo below shows the components for the N31 halyard carrier, but although they look physically different the carriers and drums are very similar internally, each containing a single standard deep groove carbon steel ball bearing, grease lubricated, and protected either side with a standard nitrile rubber double lip oil seal with sprung skirts and steel shells. The nitrile cases were heavily degraded, but not apparently by sunlight because the lower seals were in a similar state. The encased steel shells were heavily rusted, which is hardly surprising after 15 years. Profurl claim their current seals have stainless steel inserted shells. The drum and carrier used the same size bearings and seals, and the seal dimensions and bearing # were stamped or moulded into each component.

The anodizing had indeed worn through on parts of the sealing surfaces of both furlers, but since the bearings had not actually collapsed the marks were smooth and shallow, and would probably seal satisfactorily for sometime yet, especially in conjunction with fresh grease. More significant were a couple of scratches caused in extracting the circlips, which I smoothed out as best I could with a very fine emery stone.
