New skeg on my Leisure 27 "YELLOW DREAM"

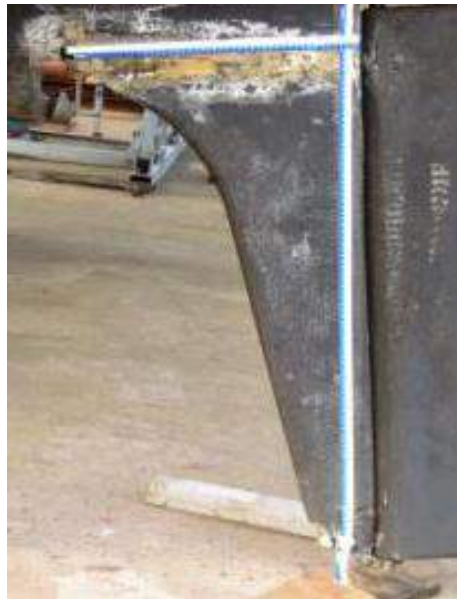
After buying my Leisure 27 last year and "YELLOW DREAM" was lifted at the end of the sailing season a nasty crack appeared at the joint between the skeg and the hull.

When I started wiggling the skeg I noticed some movement in the joint so there might be a more serious defect.

However because inside the boat the bolting was fine there had to be some kind of detaching between the steel skeg frame and the grp skeg.

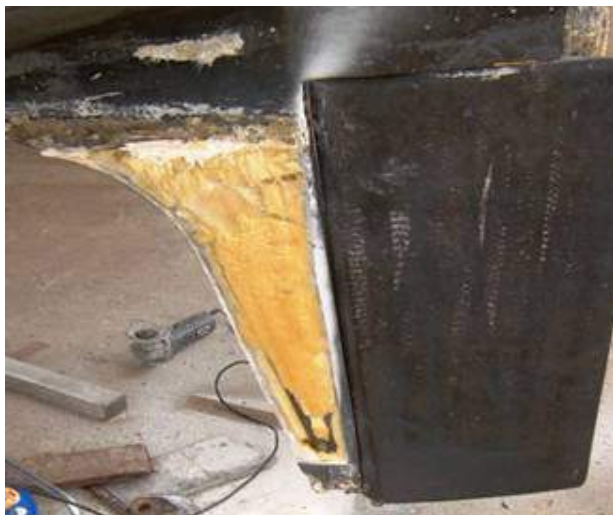
Looking at the joint I could clearly see some previous repair had been made, however not very professional.

I could have made a new repair for the bond between hull and skeg but I rather decided to remove the skeg and either repair or rebuilt it.

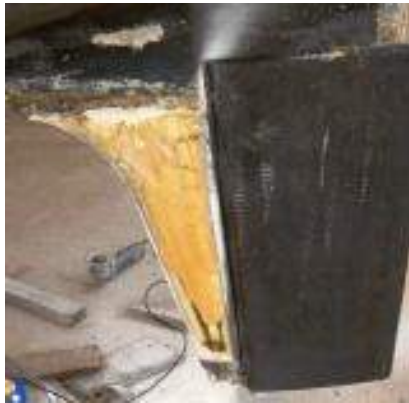
After that the grp covering could be pulled off surprisingly easy revealing the foam core. There appeared to be almost no constructive bonding between the internal steel structure and the upper grp laminate. Most of the bond was the PU foam filling which is off course not a very strong bonding agent.

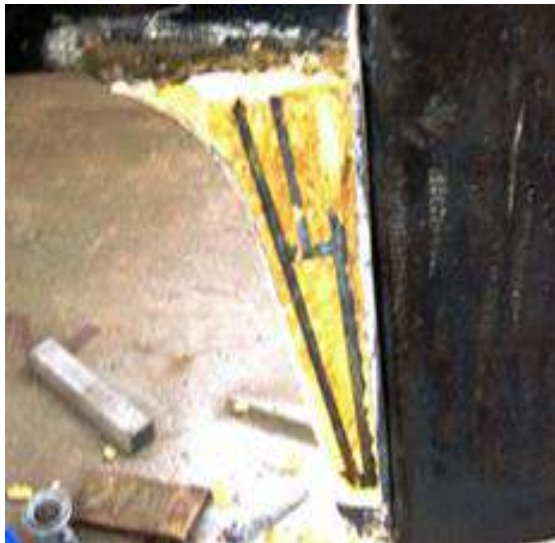
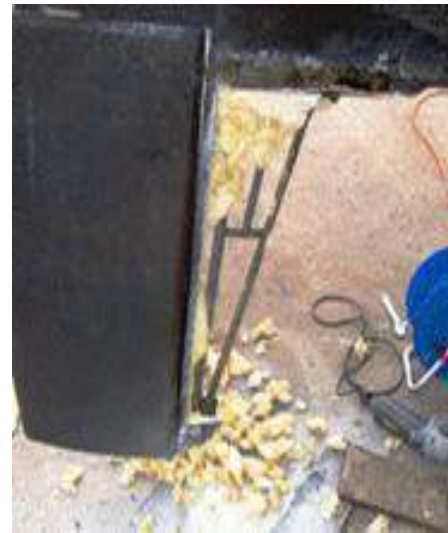
A misalignment of part of the bolting and the steel pipes that form the main structure of the skeg. Because of this misalignment forces put on to the skeg cannot be transferred by the bolting to the hull directly but can deform the hull plate as shown in this case.

original construction with bolting
not in line with skeg construction.
leads to bending of hull plate.

So, apart from rebuilding the grp part I also had to improve the steel construction. I removed two of the bolts (as can be seen in the pictures) And replaced them as close to the pipes as possible. I also added an extra rod made from a threaded rod of 12mm covered with a pipe. This way the total skeg surface area will be larger which will reduce the typical weather helm of the Leisure 27. The rod was welded to the lower skeg plate and secured by a nut under the upper hull plate which was then secured by a tag weld. This way all forces from this front rod, which is most affected by grounding, are lead into the hull directly.
