Wrong location of stern cleats on the Leisure 27/29

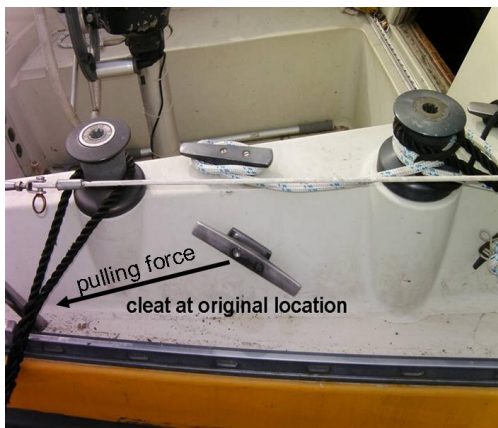
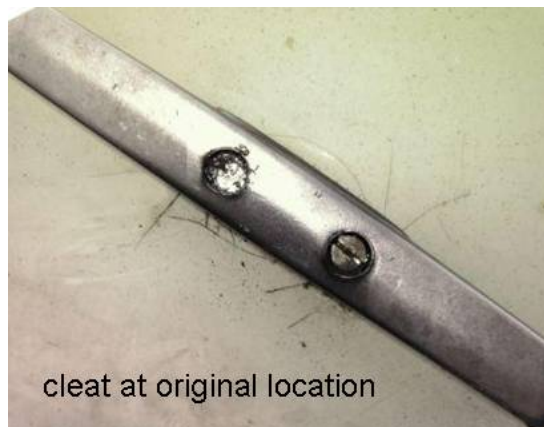
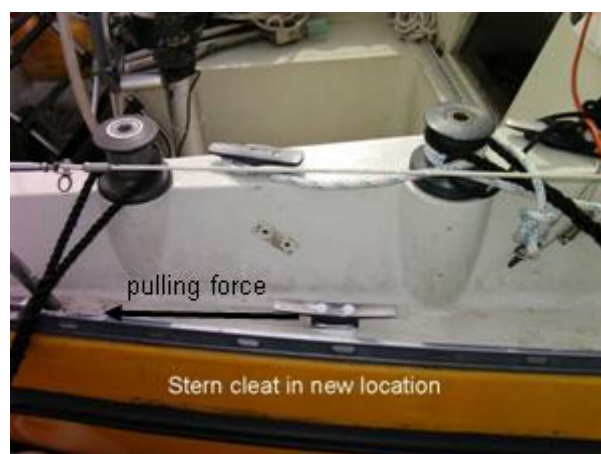
Looking at the hole I saw that the grp thickness behind the cleat only about 3-4 mm and that the cleats were attached without any reinforcement! Also the forces that will be on the cleat are not in line with the cleat which is quite a bad construction. So the original construction of the stern cleats at the Leisure27 (and probably also on the L29) is definitely insufficient for the forces involved and can be conceived as a construction fault.

So I started removing the cleat that was still in its place (as you know the other one was already torn off). It can be clearly seen that this cleat (starboard side) has also weakened the GRP and several cracks can be seen on one of the photos below. I removed the cleat by drilling out the bolt heads from outside to avoid a nasty job inside the cockpit locker.

I chose a new location at the gunwale just below the original place at the coaming taking care of the accessibility of that location underneath the GRP from the cockpit locker and the quarter berth. The thickness of the GRP at the gunwales being 8mm (instead of 4 at the coaming!) already gives a much better strength. Also most of it is already reinforced for the toerail.

The cleats were installed using a firm piece of 20 mm plywood, glued in place with glassfibre/polyester paste as reinforcement.

Because I found the original 1/4" bolts a bit cramped I also enlarged the holes in the cleats to 8.5 mm for use of 8mm bolts.
