## Wrong location of stern cleats on the Leisure 27/29

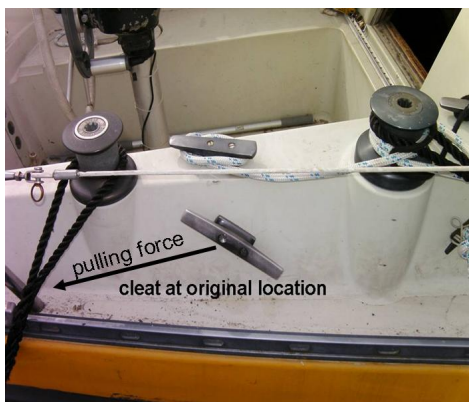
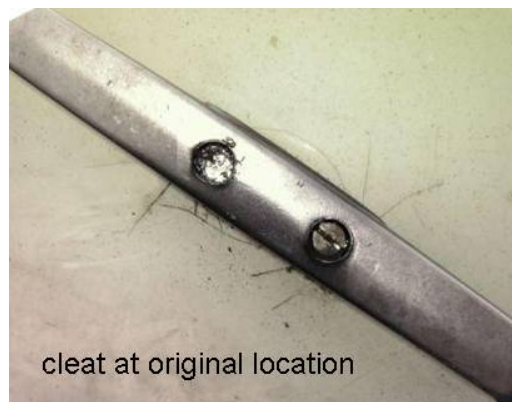
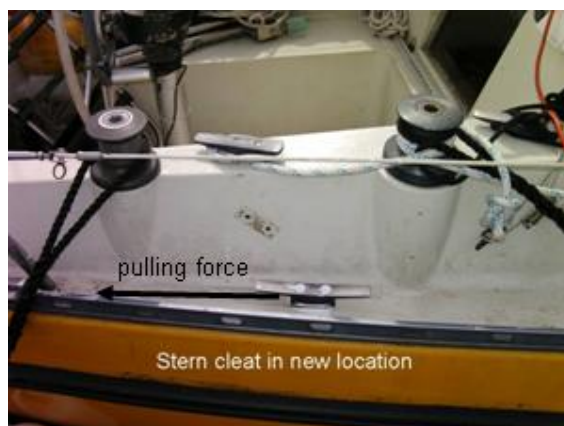
Looking at the hole I saw that the grp thickness behind the cleat only about 3-4 mm and that the cleats were attached without any reinforcement! Also the forces that will be on the cleat are not in line with the cleat which is quite a bad construction. So the original construction of the stern cleats at the Leisure27 (and probably also on the L29) is definitely insufficient for the forces involved and can be conceived as a construction fault.

So I started removing the cleat that was still in its place (as you know the other one was already torn off). It can be clearly seen that this cleat (starboard side) has also weakened the GRP and several cracks can be seen on one of the photos below. I removed the cleat by drilling out the bolt heads from outside to avoid a nasty job inside the cockpit locker.

I chose a new location at the gunwale just below the original place at the coaming taking care of the accessibility of that location underneath the GRP from the cockpit locker and the quarter berth. The thickness of the GRP at the gunwales being 8mm (instead of 4 at the coaming!) already gives a much better strength. Also most of it is already reinforced for the toerail.

The cleats were installed using a firm piece of 20 mm plywood, glued in place with glassfibre/polyester paste as reinforcement.

Because I found the original 1/4" bolts a bit cramped I also enlarged the holes in the cleats to 8.5 mm for use of 8mm bolts.
