Wrong location of stern cleats on the Leisure 27/29

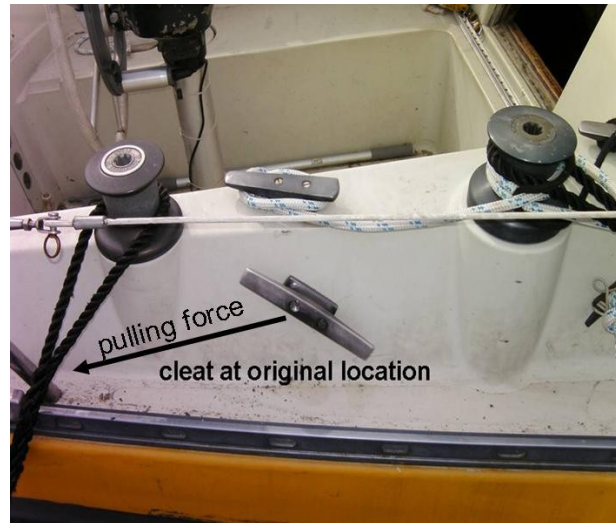
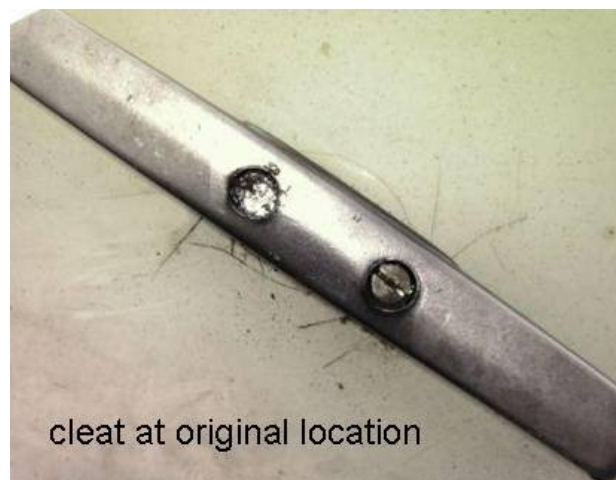
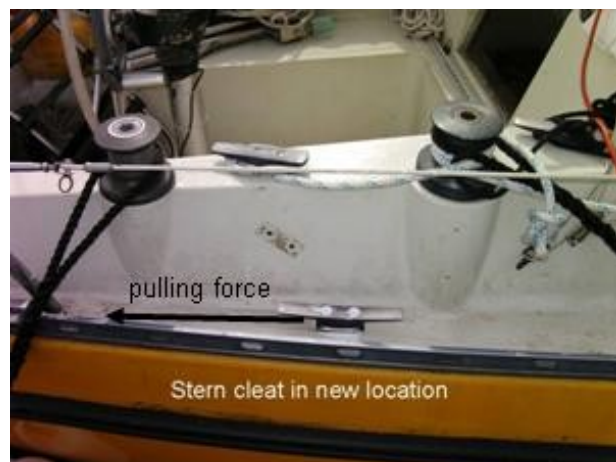
Looking at the hole I saw that the GRP thickness behind the cleat only about 3-4 mm and that the cleats were attached without any reinforcement! Also the forces that will be on the cleat are not in line with the cleat which is quite a bad construction. So the original construction of the stern cleats at the Leisure27 (and probably also on the L29) is definitely insufficient for the forces involved and can be conceived as a construction fault.

So I started removing the cleat that was still in its place (as you know the other one was already torn off). It can be clearly seen that this cleat (starboard side) has also weakened the GRP and several cracks can be seen on one of the photos below. I removed the cleat by drilling out the bolt heads from outside to avoid a nasty job inside the cockpit locker.

I chose a new location at the gunwale just below the original place at the coaming taking care of the accessibility of that location underneath the GRP from the cockpit locker and the quarter berth. The thickness of the GRP at the gunwales being 8mm (instead of 4 at the coaming!) already gives a much better strength. Also most of it is already reinforced for the toerail.

The cleats were installed using a firm piece of 20 mm plywood, glued in place with glassfibre/ polyester paste as reinforcement.

Because I found the original $\frac{1}{4}$ " bolts a bit cramped I also enlarged the holes in the cleats to 8.5 mm for use of 8mm bolts.
