INSTALLING MID-SHIP CLEATS ON A LEISURE 27

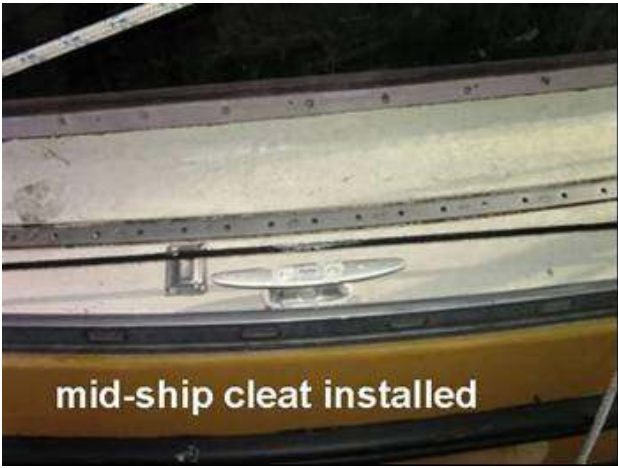
9

mid-ship cleat installed

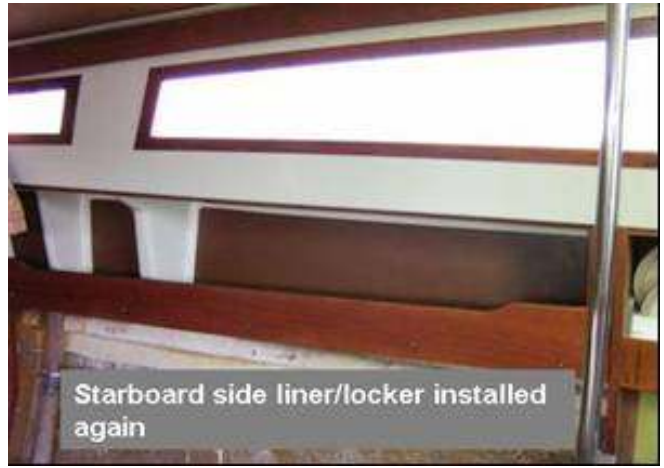
10

Starboard side liner/locker installed again
