INSTALLING MID-SHIP CLEATS ON A LEISURE 27

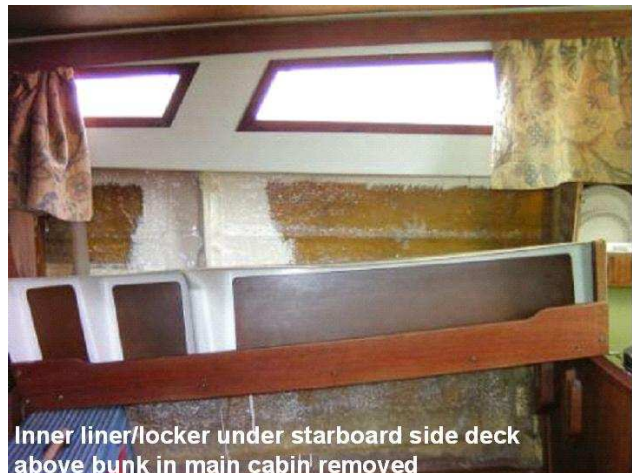
Inner liner/locker under starboard side deck above bunk in main cabin removed

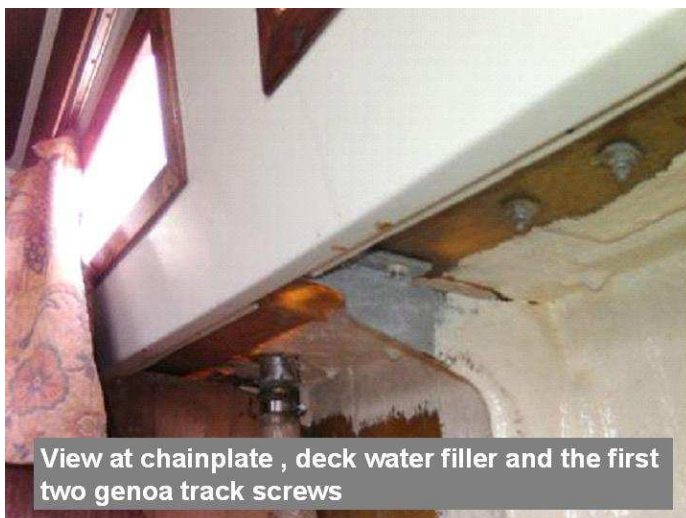
Another additional advantage was that this way I can inspect the bolting of the genoa track and the chainplate construction! That looked very tight and leak free.

View at chainplate , deck water filler and the first two genoa track screws
