## Rebedding the chainplates on a Beneteau 343

January 13, 2016

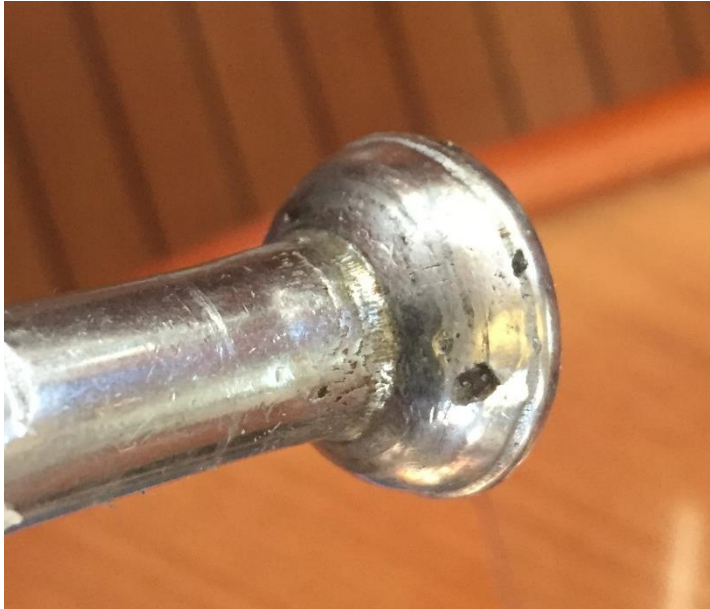
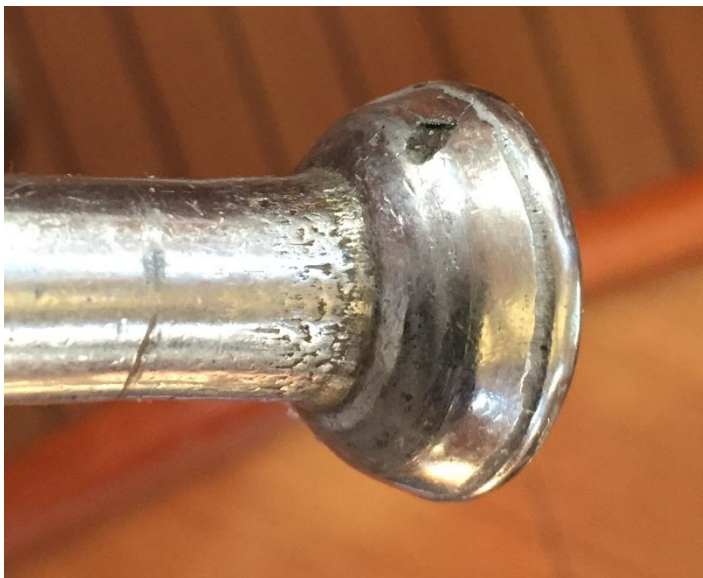
I need to keep an eye on this lower portside shroud stud. Water seems to have gotten trapped inside the chainplate cover and caused a bit of corrosion. My plan is to take the rig apart again in 18 months.

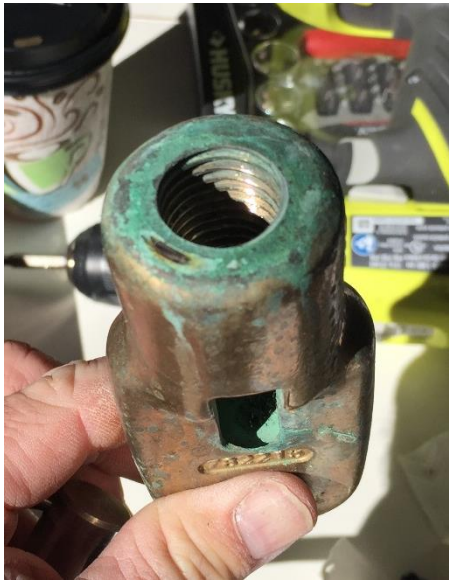
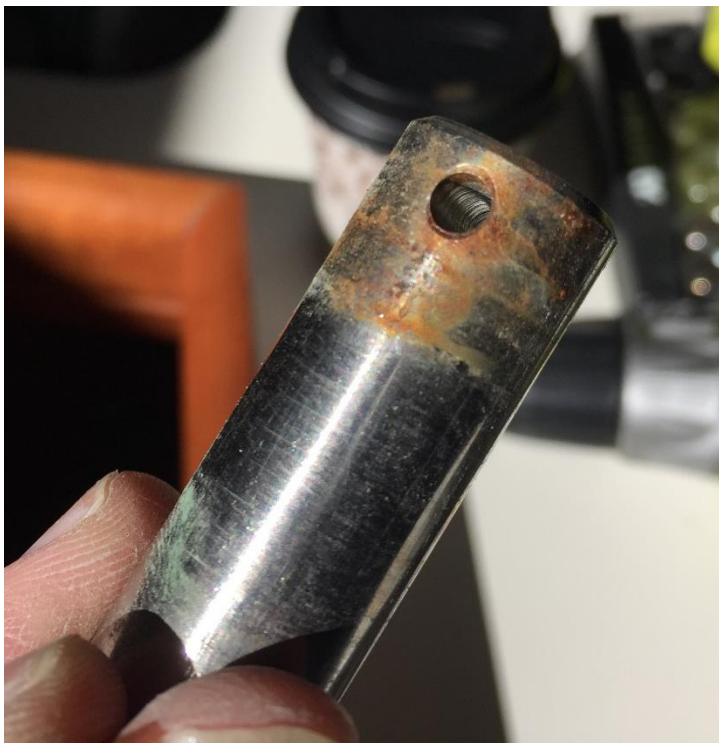
The port tie rod turnbuckle and clevis pin were clearly affected by the water that got in via leakage.

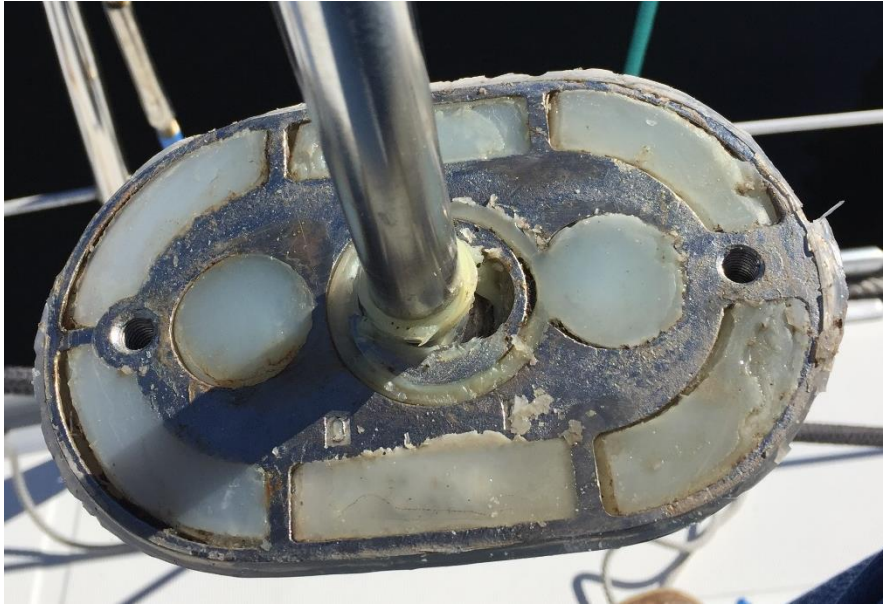
Here is what the starboard side chainplate cover looked like upon removal. There wasn't any meaningful silicone between the deck and the cover. No wonder I had leakage but thankfully no corrosion.

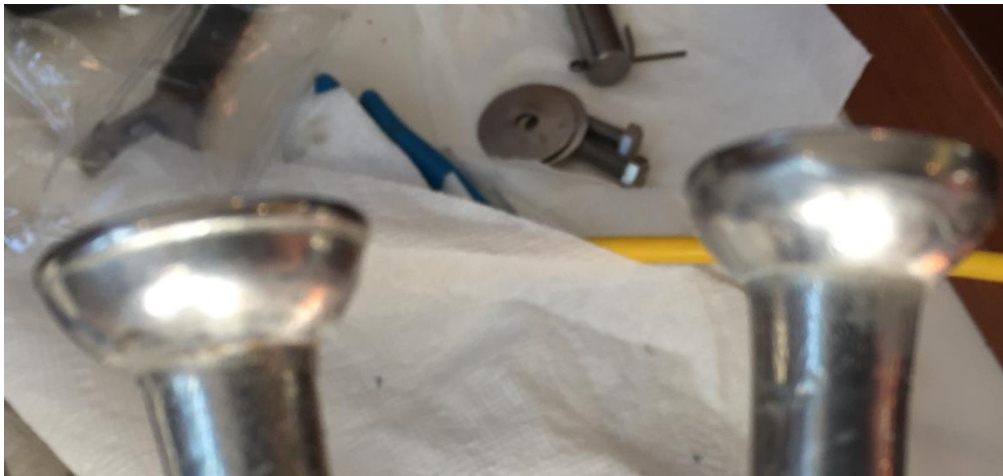
The starboard lower shroud studs are in good shape:

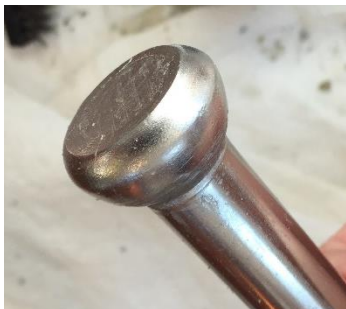
The tie-rods were in good shape:

A collection of mechanical parts laid out on a light-colored, textured surface. The parts include a large, oval-shaped metal bracket with two circular cutouts and two smaller circular holes on the sides; two screws, one with a hex head and one with a flat head; two circular metal discs with a central hole; a small metal rod with a threaded end; and a long metal rod with a blue handle.

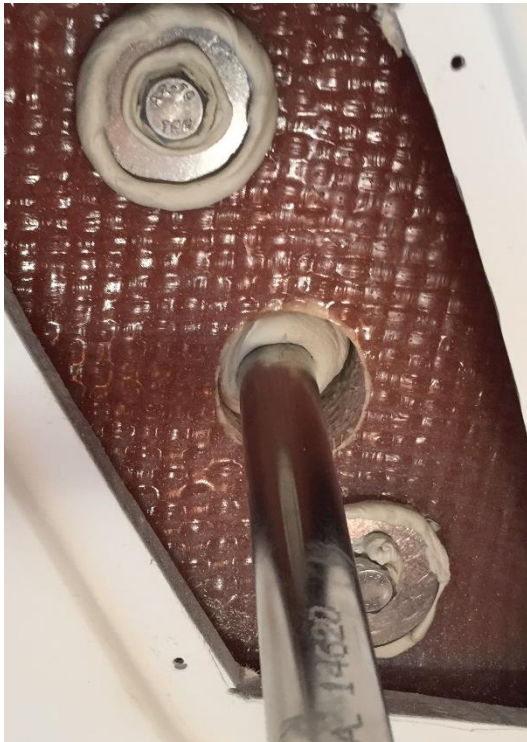
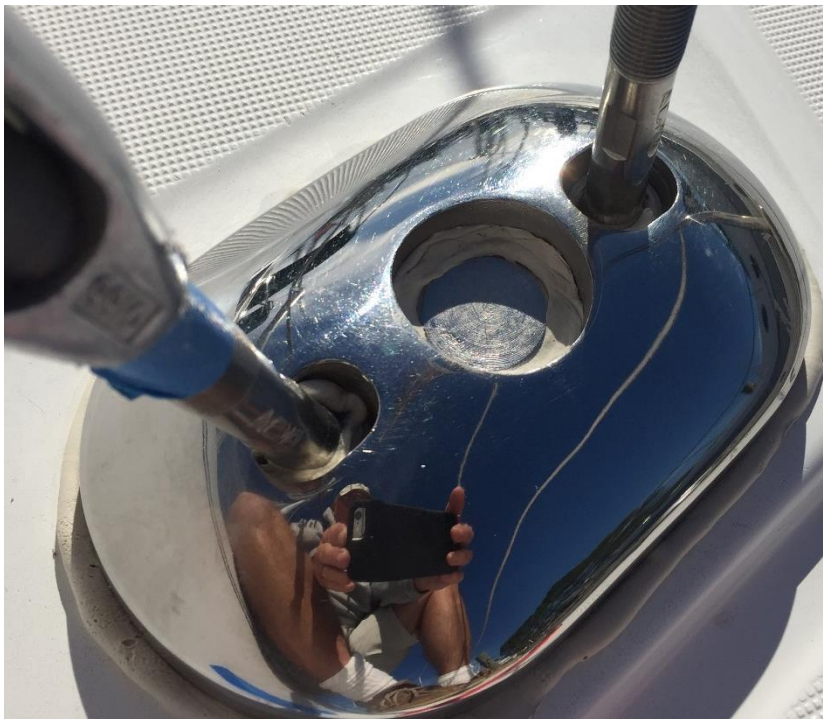
After reinstallation and during the tightening process. Notice the butyl squeezing out:

Since I used butyl to rebed the chainplate covers, I tightened the two bolts over the course of 3 days. The first tie rod I dealt with got reinstalled fully but on the second I left it a half turn loose for one day before completing the reinstall. The butyl is squeezed out over time so repeated snugging up is needed.

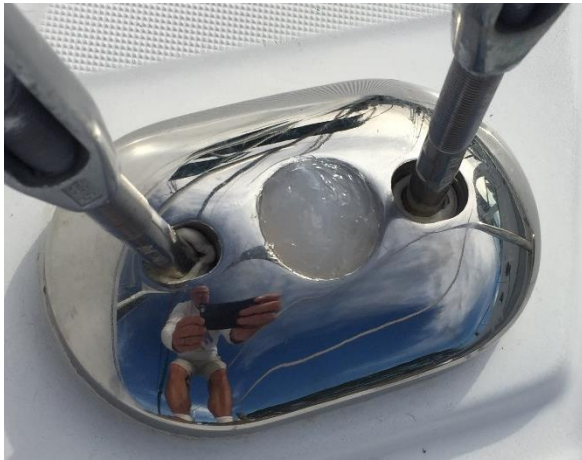
And after filling the center hole on top of the chainplate cover with marine grade silicon. It is the only silicon used in this job. I didn't use butyl since there was no way to secure it. I figure this small amount of silicon won't be too bad to remove the next time I take things apart.
