J/30 Rhapsody #348

Transmission Disassembly & Clutch Resurface

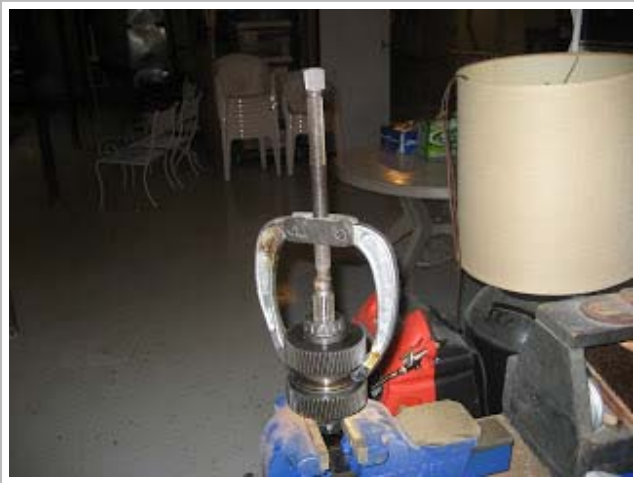
The transmission main drive shaft was setup in a vice and a bearing puller used so that the gears and bearings could be removed. The inside of the gear is the mating surface for the conical clutch.

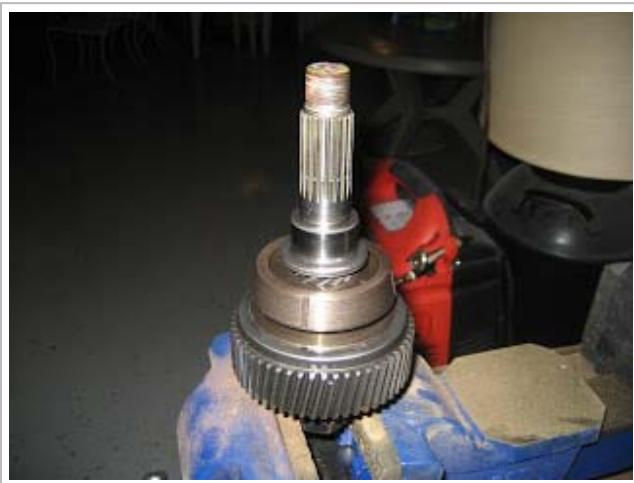
This picture below shows the top gear removed and one surface of the conical clutch. The clutch face has concentric rings that are about 1/32" wide. These are what mate with the inside surface of the drive gear.

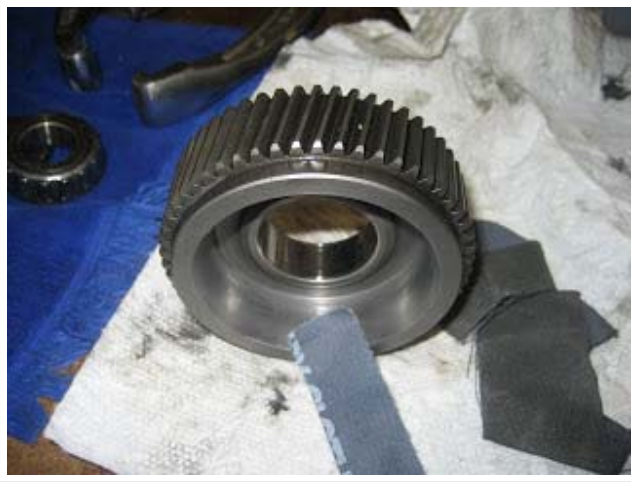
Below is one of the drive gears that has the inside surface shown. This becomes a highly polished glazed surface caused by the clutch rubbing against it. I've used fine emery cloth to remove the glaze. This is all done just by rubbing the emery cloth across the surface by hand.

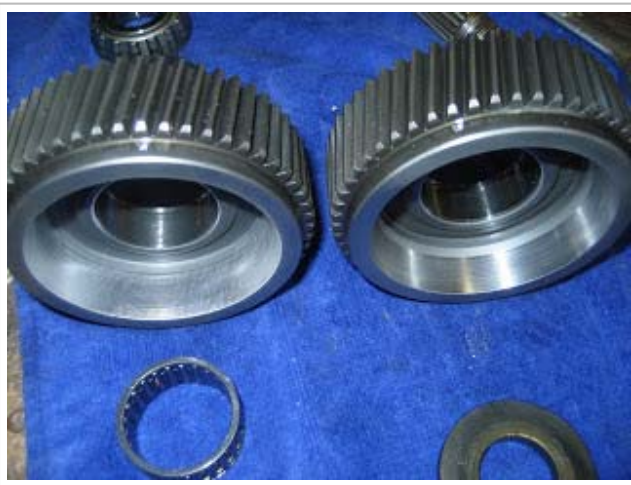
The picture below attempts to show one gear with the glazed surface on

the right, and a gear that has been lapped with emery cloth to remove the glaze on the left.

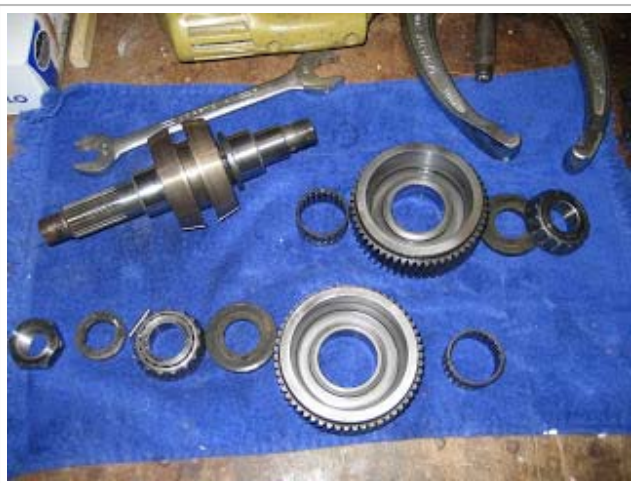
I've kept all the pieces laid out the same way they came apart. This should help get them back together correctly.
