QUICK VOLVO ENGINE OVERHAUL BY JOHN HASKER

BABY STAY BULGE BY GRAHAM AND TANYA LEECH

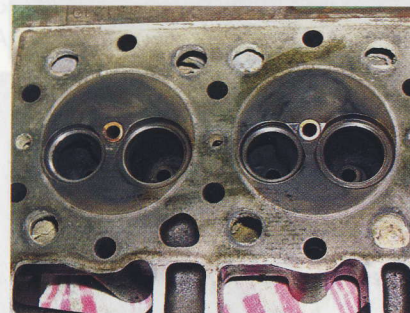
Cylinder head showing re-cut valve seats

Should we just grind in the valves with fine grinding paste, or renew all valves and get the valve seats recut? The photos show the valve seats before and after they were cut, and as new valves are only £30 each, with the new valves and re-cut seats only very light

grinding was required. To check the sealing of the valves leave the head upside down with the valves and springs fitted and put paraffin in the combustion space. If the paraffin does drain out overnight, the valve needs further work.

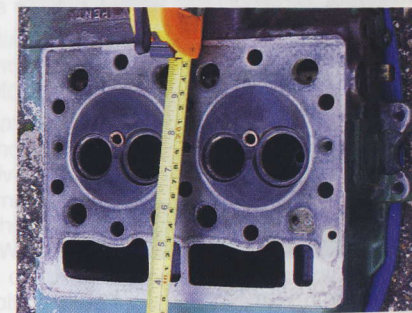
Cylinder Head showing pitted exhaust valve

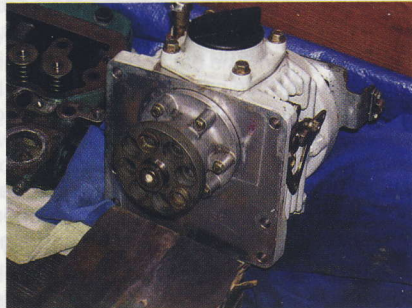
Gearbox input shaft, showing damper plate and sleeves

A lot has been written about the gearbox input shaft spline failure, so if your gearbox has not yet been modified, now might be a good time to do it. Our gearbox had the modification done 6 years ago and the damping sleeves that fit over the Allen bolts were still in good condition. After the gearbox is off, the starter motor can be removed then the flywheel. This leaves the flywheel casing to take away before we can take off the sump. As we have not taken off the timing gear casing, there are two lots of bolts to remove, the sump set and those securing the timing casing to the sump. The sump set will include bolts and guide sleeves for the crankshaft forward and aft main bearings.

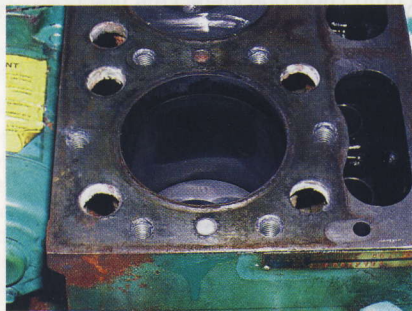
Polished cylinder bore, not what we want

With the cylinder head off and the sump removed we can now remove the pistons and con-rods. Note that the top of pistons are marked with an arrow pointing to the camshaft side of the engine and the con-rod caps are numbered with their con-rods. As we are going to remove the glaze from the cylinder bores by using a honing stone, its a good idea to cover up the crankshaft bearing surfaces to keep them clean. The photos show the cylinder bores before and after treatment with an oiled honing stone, the final dull matt grey surface giving plenty of roughness for the process of bedding in the new rings and providing minute oil reservoirs for sealing the piston rings which in turn gives good compression. There is no point in renewing the piston rings without removing the glazed surface of the bores.

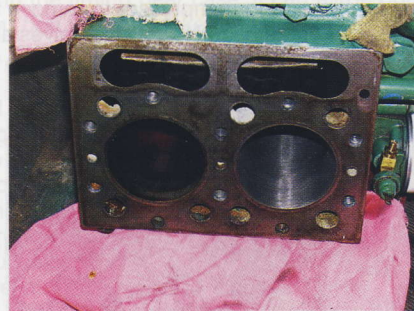
Only forward cylinder bore has been honed so far

In doing all of the above, I was fortunate in several ways. For recutting the valve seats I was charged an hour's labour and I was able to borrow a honing tool for the bores from the same engineer. A word of caution with the honing tool, its easy to get carried away with this and remove too much of the bore, we only want to take off the glaze, no more. I also have my own workshop manual, torque wrench, valve spring compressor, piston compressor, molybdenum grease, vernier micrometer, welding set, used for making up the lifting beam and a good selection of hand tools. There were delays waiting for delivery of parts through the post, also one piston ring was received in a broken condition, more delay. Several local Volvo suppliers would order parts by post, so it was just as simple order parts myself through Volspec, although there may be a handling charge. However, I now have an engine that starts easily, runs well and should only require simple annual maintenance for a few years yet.

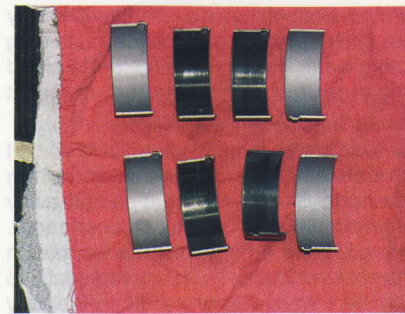
Old and new bottom end bearing shells

The crankshaft bottom ends can be checked for ovality, it seems strange that these well lubricated bearings can actually wear, but they do, and its easy enough to fit new bottom end white metal bearing shells. A decent torque wrench is required to do up the bottom ends, in the two steps as given in the manual. After tightening each bearing on the crankshaft, just make sure it can be turned by hand and that nothing has bound up. A new piece of jointing will be required at the front face of the sump and also a tube of RTV jointing for the mating surfaces of the sump. Don't forget that the sump casing holds the crankshaft main bearing shells in place, so care is needed with the sealant. After fitting a new seal and 'O' rings the flywheel casing can be bolted on and tightened up.

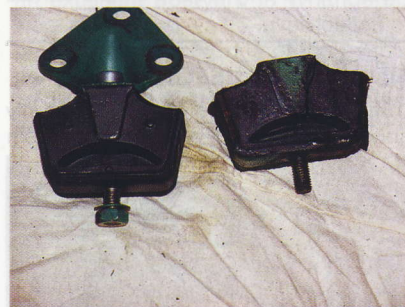
Old and new flexible mountings

With the engine the right way up, the flywheel, starter motor, cylinder head can all be refitted in turn, using the manual for details of correct tightening torques. Getting as much as possible back together before putting the engine back in place gives us more space in the cabin and also a chance to give the engine bay a good clean while its accessible. The threads in the holding down bolt pads were also cleaned up using a thread tap. Giving the flexible mounts a good twist revealed that both front mounts were cracked, so time to renew them.

As we replaced the two forward flexible mountings, the alignment will need to be adjusted, so slacken and just nip up the nuts that adjust the vertical alignment before replacing the engine.

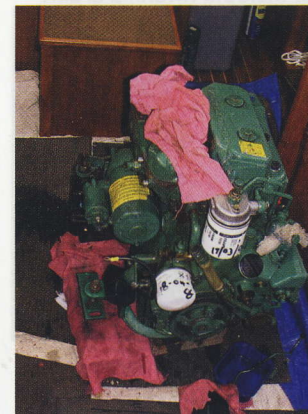
Reassembled engine, note slot in mounting plate and rag tied round fuel pump banjo bolt

The plates that bolt directly to the bearers have a hole at the aft end and a slot at the forward end. This allows the engine to swivel and move side to side if required during engine alignment. Using the nuts on the four mounting plate studs, the up and down position of the engine can be adjusted. What we are trying to achieve is that the two halves of the coupling are parallel to each other and in line before bolting them together. This is another job that is easier with two of you, one each end of the engine to make the adjustments as necessary.

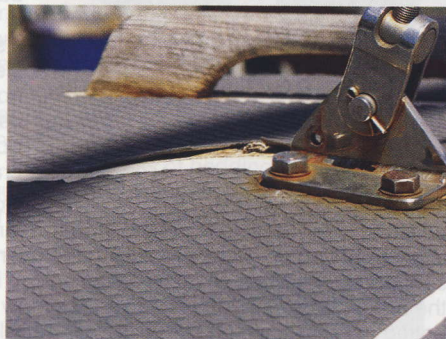
Walking across the foredeck of our Corsair (CS118), *Thursday's Child of Lee*, I suddenly noticed a great bulge in the deck around the baby stay. My heart sank – yet another problem to add to the growing list. We'd laid the boat up ashore in a yard in Tahiti for longer than we'd intended, and in our absence, this bulge had appeared. Everything in Tahiti is expensive, the yard wasn't great and we didn't have time on our side, so we decided to re-launch and carry on sailing westwards towards our intended destination of New Zealand.

Baby stay bulge

This is a known problem with Corsairs (and other Westerlys with baby stays) but it is normally limited to some minor lifting. This is clearly an extreme case and, unless there is a defect with the deck, is caused by excessive tension being applied to the baby stay itself. Experience indicates that one of the most likely causes is by cranking up hard on the backstay at some stage. It is relatively easy to pull the masthead rearwards which puts a severe strain on the baby stay.

The solution is to cut the damaged section out of the foredeck, add strengthening cross members and make good the deck, Treadmaster and so on. Fortunately, we think the work can be carried out without interfering with the joinery of the forward heads compartment, but its still quite a major job that's going to dent our cruising budget. We're also lucky that the work will be carried out by structural GRP specialists who are experts in this field.

The role of the baby stay is to prevent the mast inverting when under heavy load. Early Westerlys had two forward lowers and a baby stay was fitted as a cost saving measure. One permanent solution is to replace the baby stay with two forward lowers attached to chain plates bolted through the deck to the saloon forward bulkhead. John Easteal's article in Edition 77 shows this permanent solution which definitely cures the problem in an elegant, but simple and straightforward way. I have carried out the modification, which incidentally also makes for easier tacking and frees up space on the foredeck.

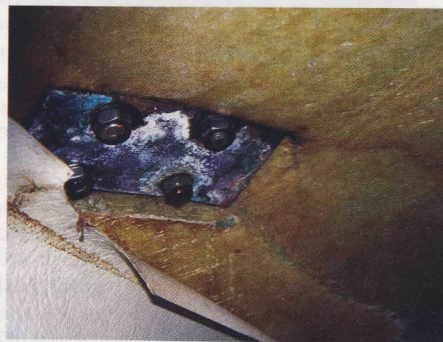
The woefully inadequate backing plate was pulled right up through the GRP

It was with immense relief that we arrived in the Bay of Islands and a week later, in an excellent boatyard in Whangerei, we were able to make a full investigation of the problem. Removing one of the headlining panels in the forepeak, revealed a pitifully small backing plate beneath the baby stay and the boatbuilders were critical of the complete lack of strengthening members across the foredeck to tie this area into the main structure of the hull.

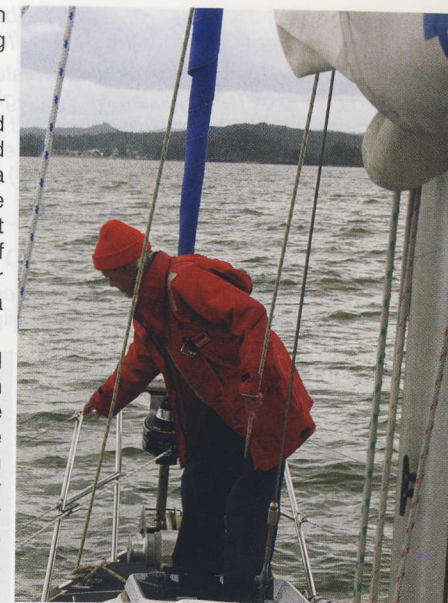
Graham on the foredeck by the safety line we rigged
