## Section 8

### Windows and Hatches

#### Windows - L17

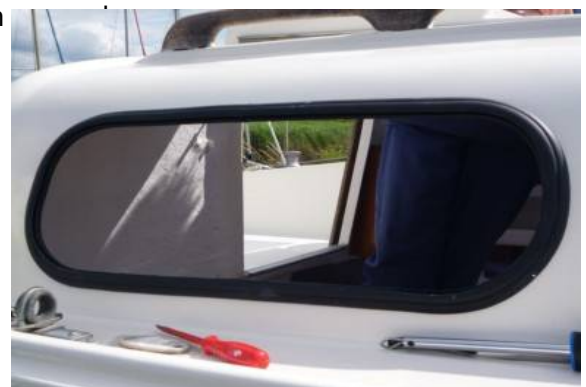
The usual size of seal to order is  
WR69 Window Section 10 x 5 mm: 9 metre length  
FS72 Black Filler Strip: 9 metre length  
GT75 Glazing Tool  
Although the original perspex is 4mm, the 5mm seal size will accommodate this.  
Cost of rubber seals is around £65 (2014)

*New Window Seal Fitted*

Once the window is in place, take the filler strip and push it into the groove on the outward face of the rubber seal, using the tool which the seal manufacturer provides. This action can be seen on Youtube videos and locks the perspex firmly in place. The correct tool from the supplier is well worth buying and you will be amazed how quickly this task is done, after the struggle getting the window into the seal.

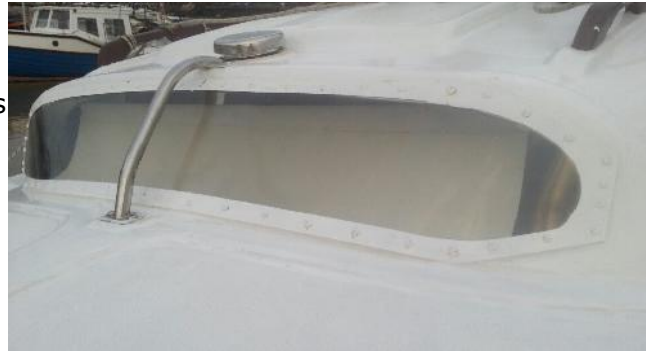
You could consider moving to the later method of window installation, used from 1975 onwards on the Leisure 17SLs and also on the Leisure 23SL and Leisure 27/29 models. In essence, this means screwing/bolting the windows to the cabin sides. The principle is to secure the window down on a neoprene rubber strip which, pressed against the cabin side, provides a waterproof seal. No adhesive (such as Sikaflex) is used on the neoprene strip and the windows can be removed later, easily.

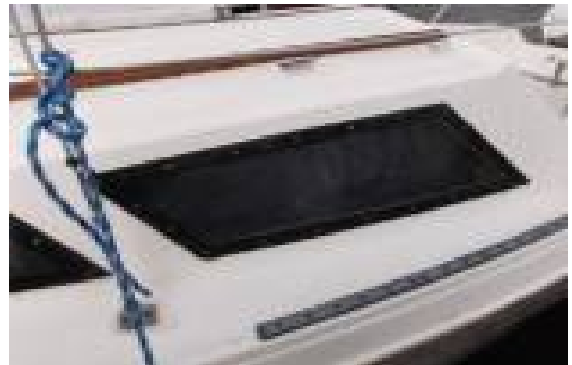
The new 'wedge shape' cabin superstructure introduced in 1975 with the Leisure 17SL, featured a move away from rubber sealed windows. The cabin sides of the L17SL were flatter and the new screw down/bolt on method of attaching windows was used.

Unfortunately the windows were sometimes secured on to a sealant which eventually leaked as it expanded, contracted and dried out in the sun. This method of attachment also makes window fitting and removal a messy business.

After removing the screws or bolts, insert a thin blade gently between window and cabin side to break the sealant. Carefully prise the window away from the cabin side. For full details on replacing the windows and bedding them down on a neoprene rubber strip, please see this article [Screw on Windows](#). There are further articles on similar window replacement carried out on an [23SL](#) and [27SL](#)

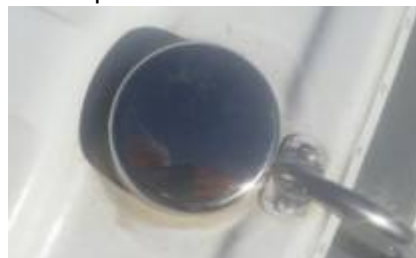
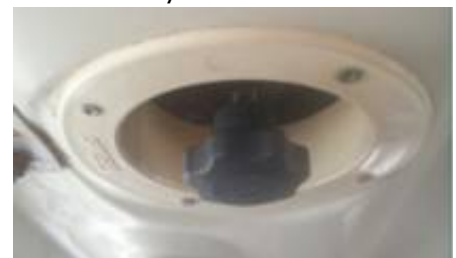
It's a "mushroom" type ventilator and can be "opened" from above or below. "Opened" is possibly an optimistic word to use since the lid or top of the ventilator does not move very far.

Inside in the cabin, there is a (large plastic) screw. Turning the screw in one direction raises up the ventilator cap, allowing the passage of air. Turning the screw in the opposite direction lowers the ventilator cap and restricts the passage of air.

It's pretty basic, and does work well enough, but the original ventilators contained a mix of metals, brass and stainless steel. Corrosion usually sets in when the screw has not been moved for a long time. Patience, WD40 and similar "freeing" sprays might loosen corrosion's grip and restore the ventilator to a working condition.

It might be easier to remove the ventilator entirely for any remedial work. It is held only by s/s self tapping screws on to a bed of sealant. The sealant will probably have gone solid with age and is probably a source of water ingress anyhow. The sealant can be removed by a sharp blade worked between deck and ventilator.

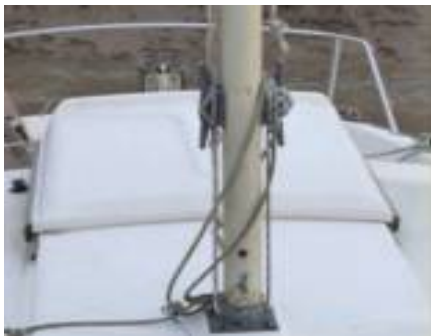
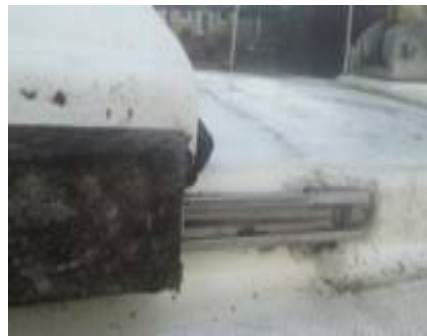
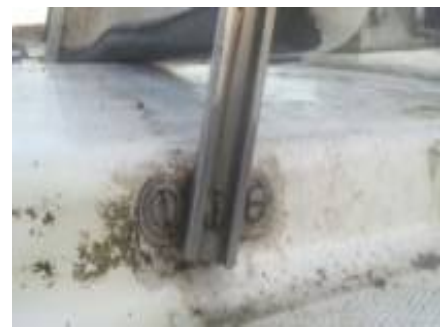
Screwed/bolted to the inside side of the hatch, through the GRP to the mahogany strip, is a female brass runner or rail. Over this brass runner slides a stainless steel fitting.

This stainless fitting is attached by just one single bolt to the cabin side at it's front end, in such a way that the stainless fitting pivots around the bolt.

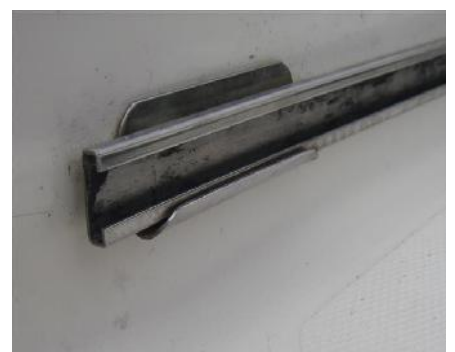
*"I measured the hatch fittings. The two SS C sections are the same C section used at the stern to carry the mainsheet slider. They're 560mm long x 19mm wide x 5.5mm deep. At the cabin end there's a small plate welded carrying a bolt that goes through the cabin side to allow the SS C sections to swing up. The two brass sections screwed to the inside of the hatch are*

500mm long x 15.5mm wide x 5mm deep.

There is also a SS rest on each side of the cabin entrance for the C sections to rest on."

It looks rather Heath Robinson but it's quite ingenious! When closed, the hatch cover is held securely. It can then be pushed forward, sliding open to about 2/3 of it's length. Finally it can be pivoted upwards to leave the hatch fully open. The upwards pivot is restricted only by the position of the boom.

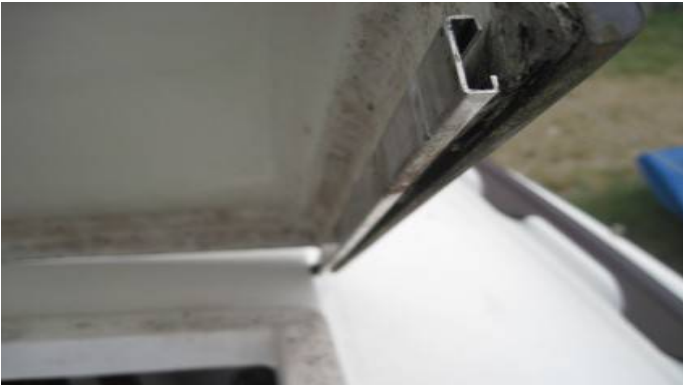
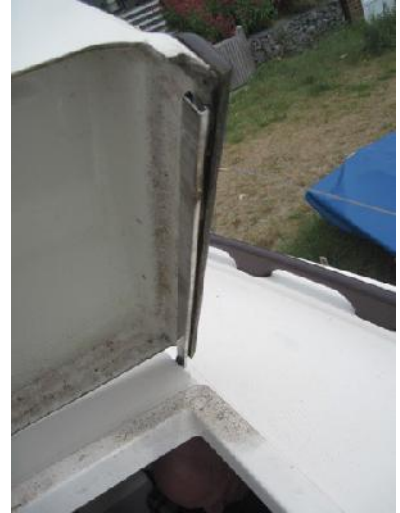
In time the metal parts suffer from corrosion, the screws holding the mahogany strips to the hull give way or the pivot bolt at the front similarly gives up the ghost.

The screws and the pivot bolts are fairly easy to replace but the s/s slider and brass counterpart are not.

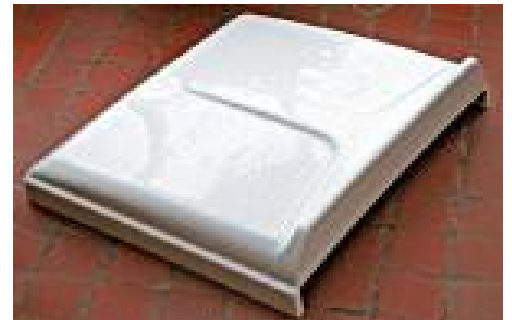
### **Replacement Hatch Cover**

New GRP hatch covers are available from [Gerry Askham at Hurst Marine](#) for around £200. However you will need to fit the timber trims and find a source for the metal fittings.

It's surprising that the LOA have not had these metal fittings in their spare parts inventory. It would need a willing owner to remove a set of fittings and submit them so that patterns could be made, but in 2014 there are plans to remedy the situation.

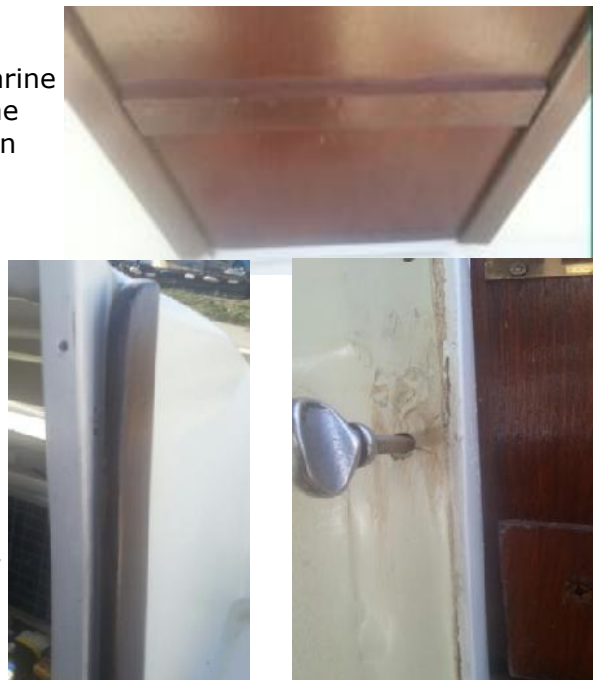
The mahogany retaining strips are held in place by long wood screws inserted from the cabin interior. The washboards slide between the GRP recess and the mahogany retainers.

Originally a s/s screw was then screwed from the inside through the GRP to grip the wash board or sometimes, into a hole in the washboard. It's an odd arrangement. Firstly this large screw pushes the mahogany retainers outward and away from their fixings. Secondly the screw thread in the GRP soon becomes worn and the s/s screw flops uselessly in the enlarged hole.

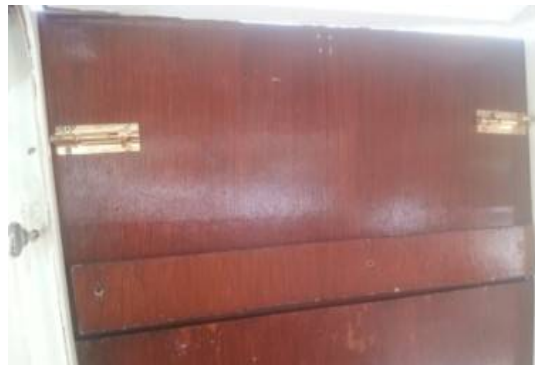
Far better to mount two **swan** necked bolts on the top wash boards. The bolts slide into corresponding holes drilled on each side of the companionway.

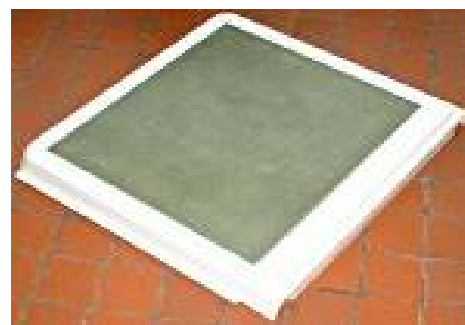
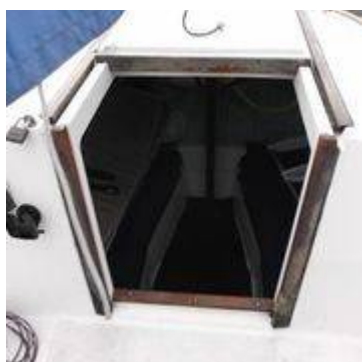
You can see from this photo of the replacement hatch offered by Hurst Marine for the 17SL, that it's quite different

The main hatch now pushes forward under two hardwood runners.

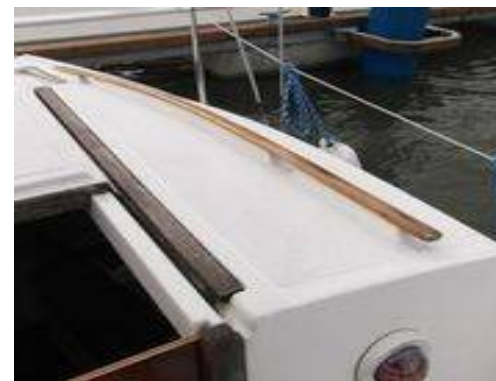
The arrangement for the washboards is also slightly different.

No metal fittings were used in the design of the SL hatch which has proved remarkably tough and fault free.

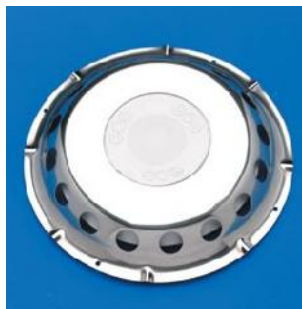
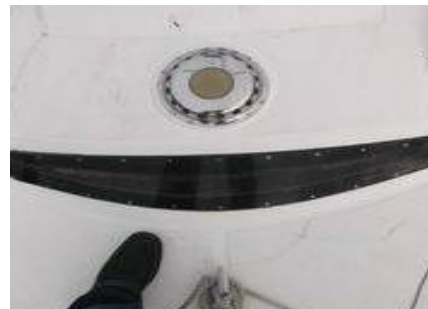
The ventilator on the later SL version is quite different as it is of the fixed, domed type. There are no moving parts but in time the internal plastic moulding does degrade, crack and leak.

If you have a puzzling leak, examine this internal moulding carefully.
