Replacing Old Profurl Bearings

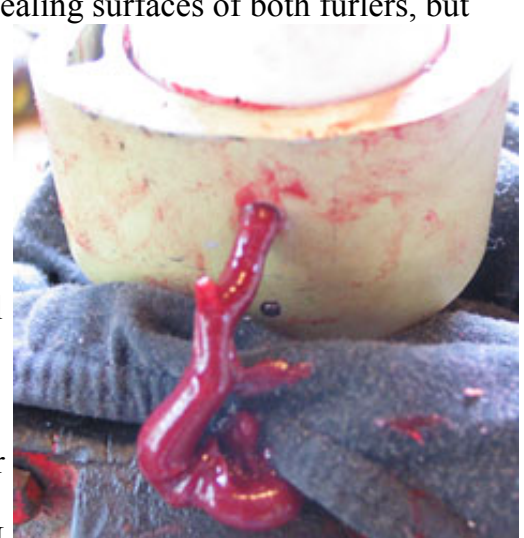
The anodizing had indeed worn through on parts of the sealing surfaces of both furlers, but since the bearings had not actually collapsed the marks were smooth and shallow, and would probably seal satisfactorily for sometime yet, especially in conjunction with fresh grease. More significant were a couple of scratches caused in extracting the circlips, which I smoothed out as best I could with a very fine emery stone.

The units had originally been grease filled, and two small stainless steel pins blanked off holes in each housing. These holes had presumably allowed excess grease to escape as the final seal was forced into the housing. I drilled and tapped new holes with 6mm internal threads directly opposite each pin. After assembling with new bearings and seals with copious "wheel bearing" grease, the excess was forced out through these holes. I then blanked them off with 6mm machine screws. My intention is to periodically fit grease nipples into one of these threads and force fresh grease through the bearing and out the other hole, in the hope that this will at least delay moisture reaching them. Unfortunately the seals are not positively retained in the housing, so using these holes to force old grease back through the seals would probably just expel the seals.
