INSTALLING MID-SHIP CLEATS ON A LEISURE 27

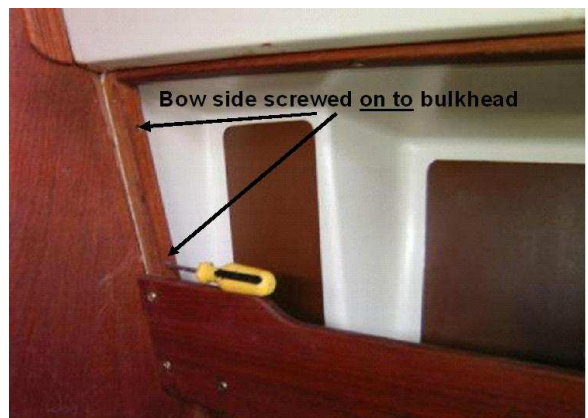
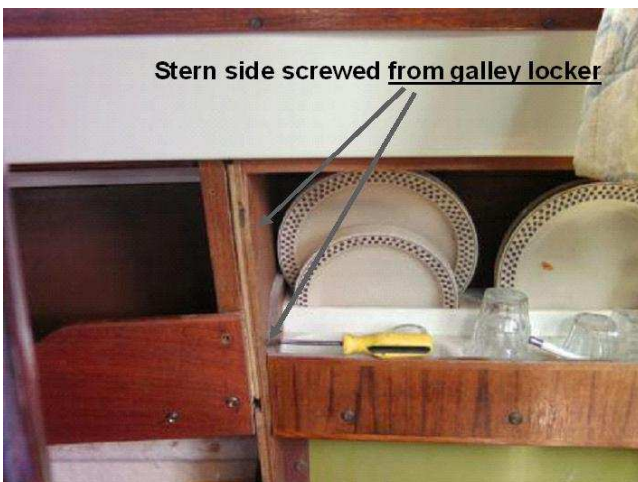
It appeared that the liner/locker is screwed at the top on to the liner below the window and at the sides to the partial bulkhead at the stern side and the main bulkhead at the bow side. So I started to remove all screws I could find and to my relief the total liner/locker came off easily!
