Bore glazing in diesel engines

By Vyv Cox

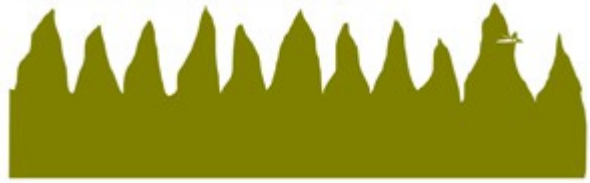
Magnified diagram
Highly magnified surface profile of newly-machined cylinder liner:peaks and troughs produced by honing

When a modern engine is built, the cylinder bores are honed, using a diamond abrasive. The intention is to produce a crosshatch appearance with scratches from both directions at about 22 degrees from the horizontal.

The microscopic surface roughness at this stage is a series of peaks and troughs, and in the past the engine was assembled at this stage. Part of the running in process was to wear off the peaks, to generate the desired 'plateau' finish.

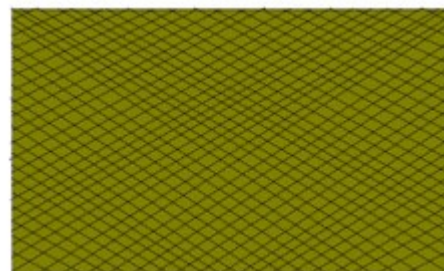
Magnified diagram
Surface appearance of honed bore

Modern practice is to machine the plateau finish, largely eliminating the need for running in. The engine delivers good compression right away, there is no blue smoke in the exhaust, emissions and oil consumption are reduced, and the rings last longer because they have not had to wear to conform to the bores.

The plateau finish is essential to ensure reliable operation of an engine. In service the troughs contain the oil that lubricates the piston rings as they pass across the cylinder. If the troughs are destroyed the piston rings will not be lubricated, causing high temperature, blow-by and rapid wear.
