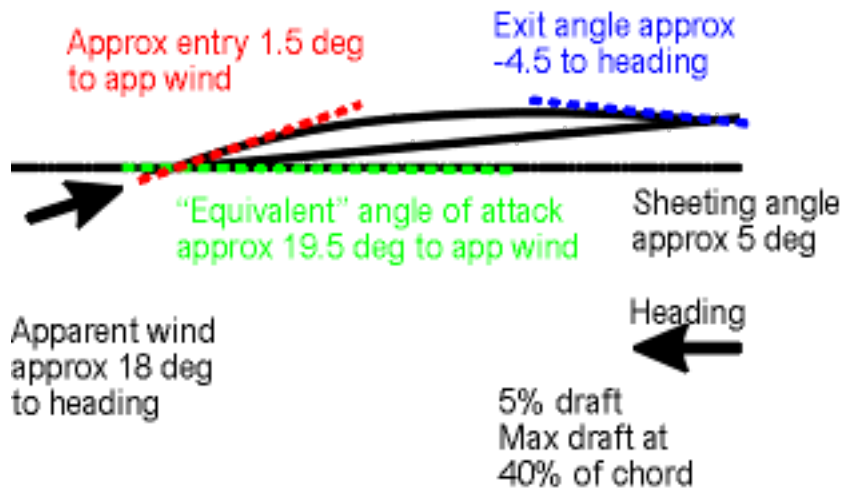
Mainsail with approx 12 deg jib downwash
