**Steel hull without anode
leading to galvanic corrosion**

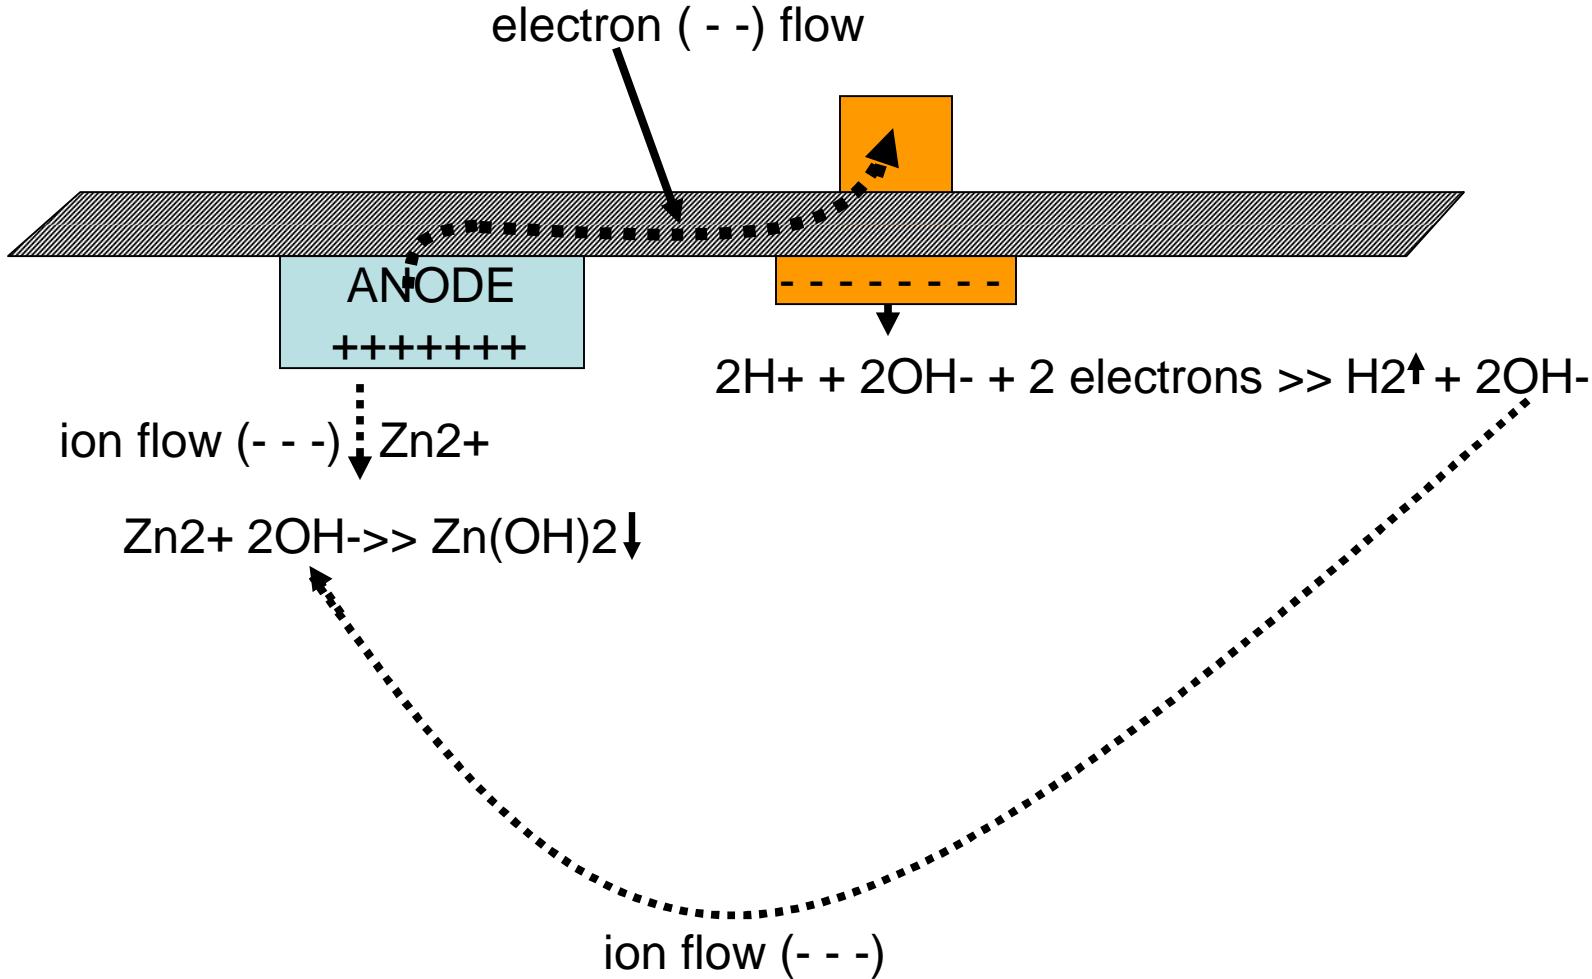
Steel hull with Zn anode closed loop but no corrosion because of protecting anode

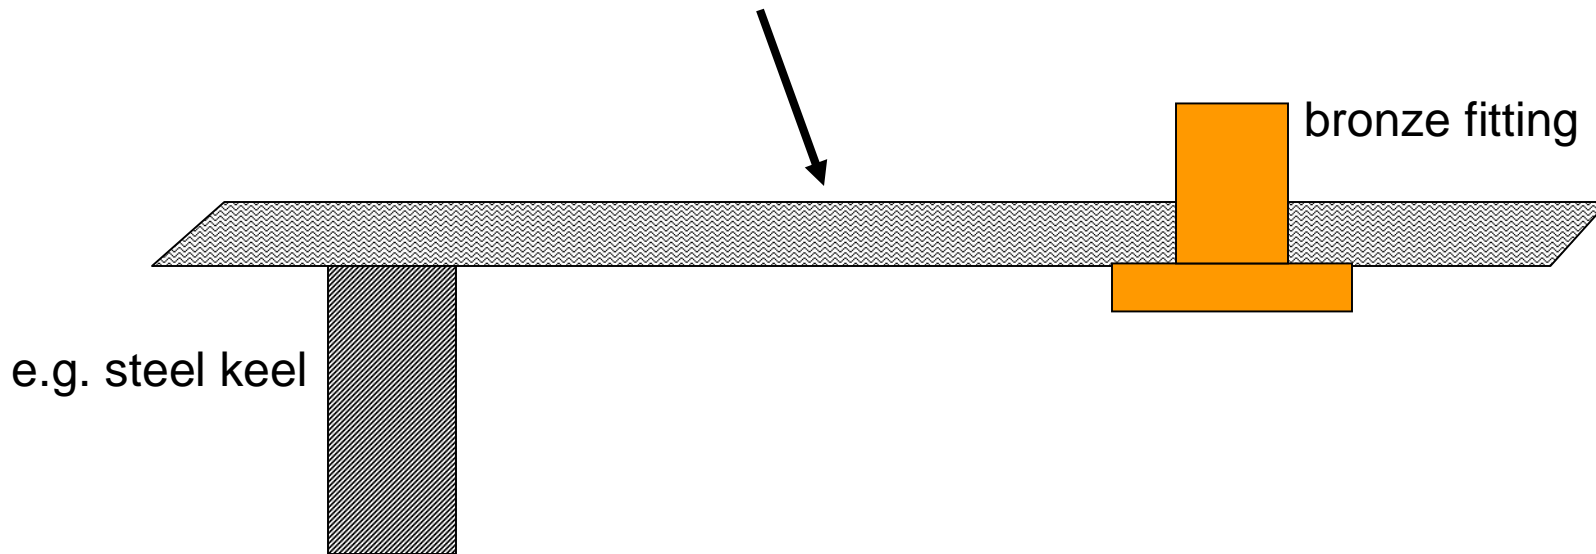
Polyester hull without anode
no closed loop > no corrosion

electrons flow not possible through polyester
no charges separation possible
>>> no galvanic corrosion

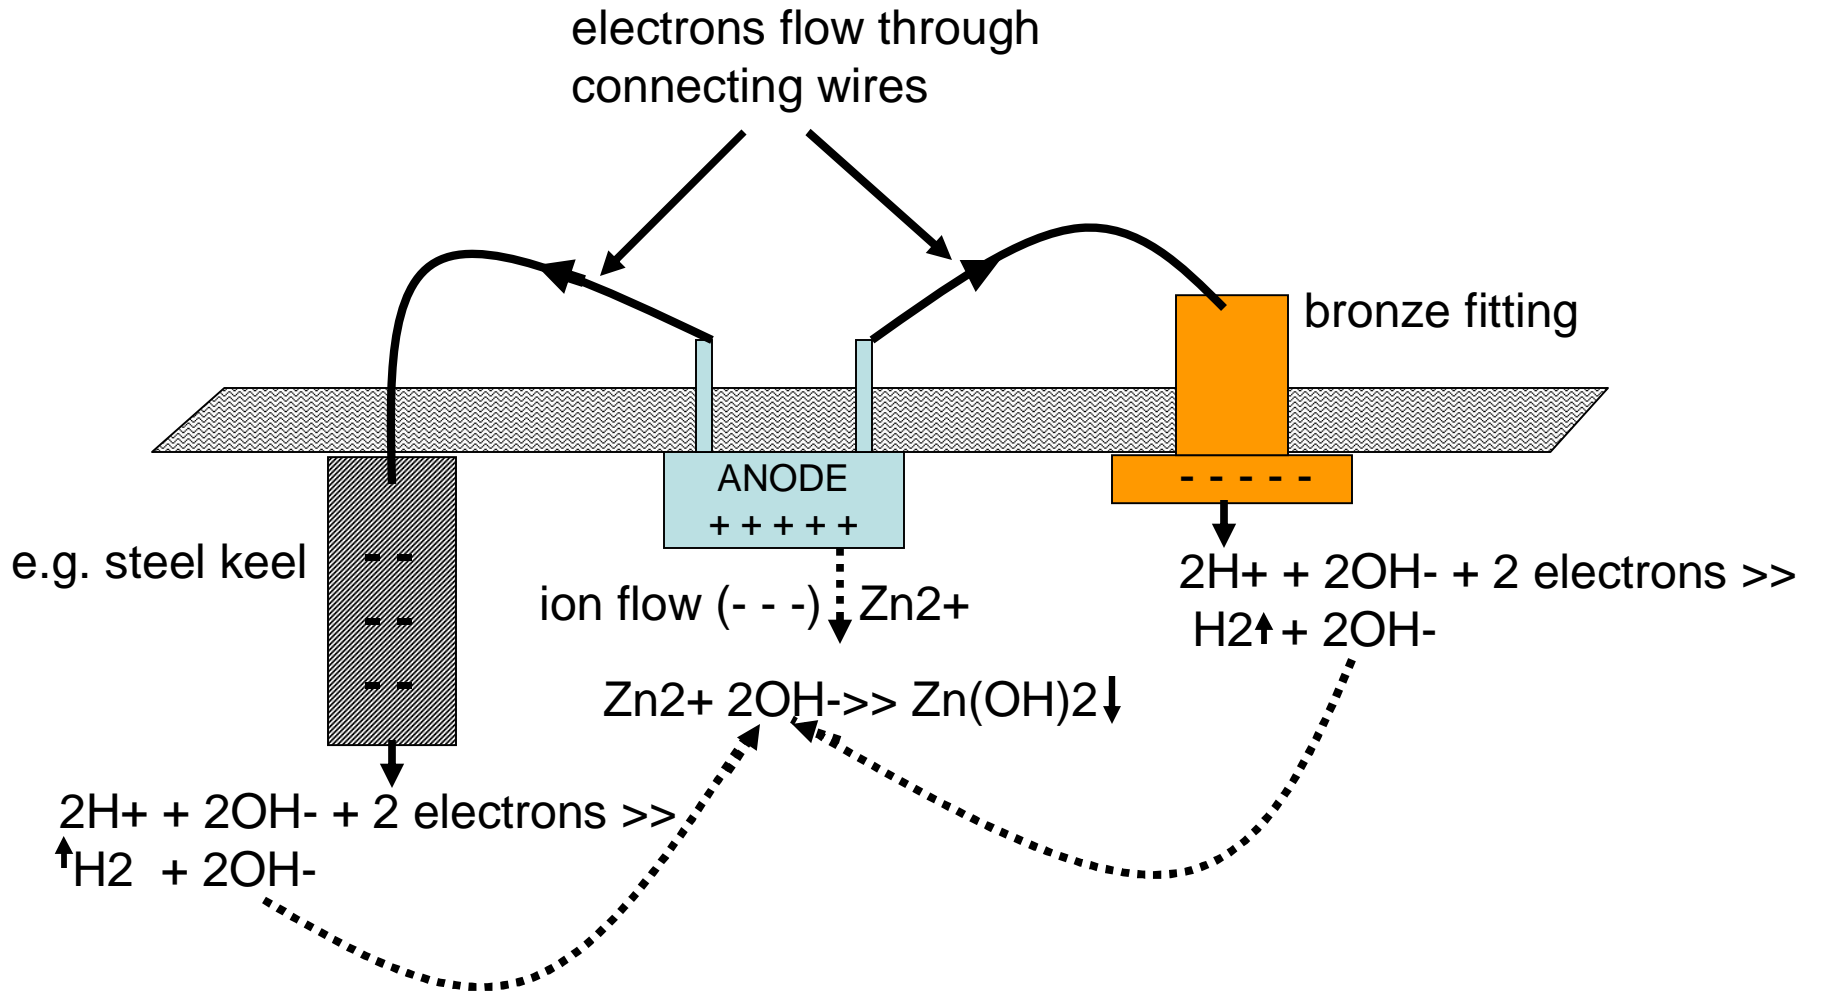
Polyester hull with anode
 connected to skin fitting and keel
 closed loop but no corrosion because of protecting anode
